# BRIDGE INSPECTION MANUAL

FOR ARBICS AND PBC

The Project for Strengthening of Capacity Development on  
Bridge Management System in the Republic of Kenya

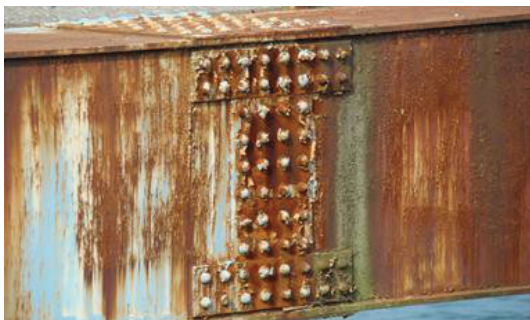
| Damage of Steel Member | Corrosion | 1/5 |
|---|---|---|
| | Although the thickness of the steel plate has hardly decreased, the corrosion-resistant coating is deteriorating over a wide area, and it is expected that serious corrosion will spread to the whole bridge if left unattended. | |

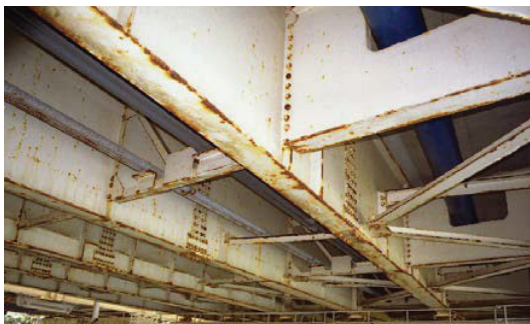
| Damage of Steel Member | Corrosion | 1/5 |
|---|---|---|
| | There is little adverse effect on the load bearing capacity of the entire bridge, but significant corrosion is progressing locally, and if left unattended, the adverse effect can be expected to spread. | |

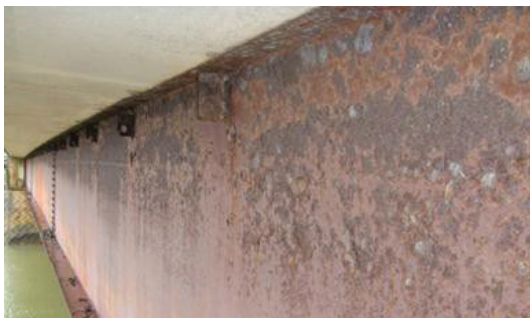
| Damage of Steel Member | Corrosion | 1/5 |
|---|---|---|
| | Although it is an atmospheric corrosion weathering steel, the thickness of the main member has not been remarkably reduced, but apparent abnormal corrosion is observed, and the condition cannot deteriorate any further even if left unattended. | |

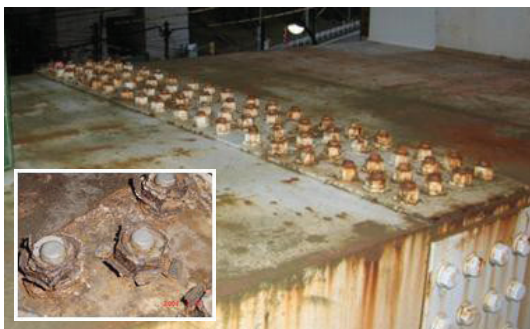
| Damage of Steel Member | Corrosion | 1/5 |
|---|---|---|
| | Although it is a painted material, the thickness of the main material has not been significantly reduced, but if left unattended, there is a possibility of rapid deterioration of the coating and spread of corrosion due to water leakage. | |

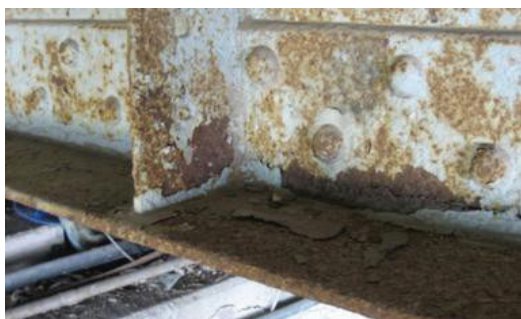
| | Significant corrosion has occurred in the main member web and lower flange, a clear reduction in plate thickness can be confirmed locally, and structural safety may be impaired if a section loss occurs. | |

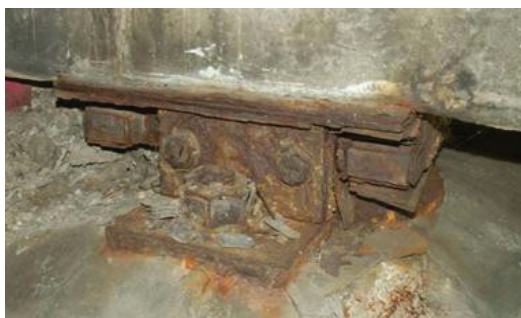
| | The main girder near the bearing and support point has significant corrosion with a clear reduction in thickness. | |

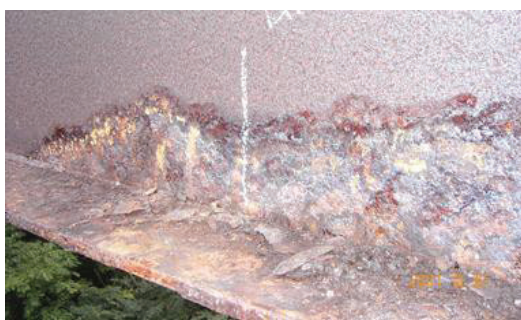
| | An atmospheric corrosion weathering steel with apparent abnormal corrosion, resulting in a wide plate thickness reduction. | |

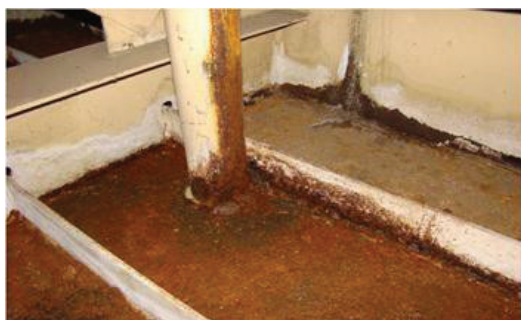
| | Severe corrosion has spread to a wide range of main member due to water leaks and water retention. | |

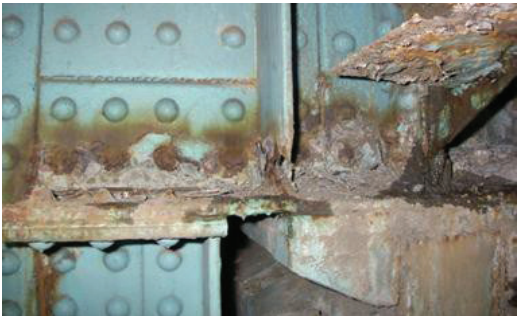
| Damage of Steel Member | Corrosion | 3/5 |
|---|---|---|
| | | There is a clear cross-section loss due to corrosion at the position important for the structure such as the receiving beam of the Gerber/cantilever hinged bridge structure. |

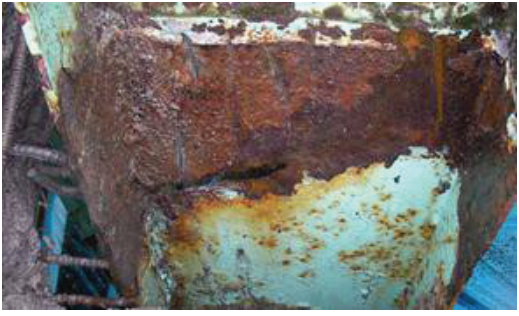
| Damage of Steel Member | Corrosion | 3/5 |
|---|---|---|
| | | Regarding truss bridges and arch bridges, the main members, such as diagonal members, columns, suspension members, and chord members, have obvious cross-section loss and significant plate thickness reduction. (Sudden rupture may also occur due to wheel load of large vehicles). |

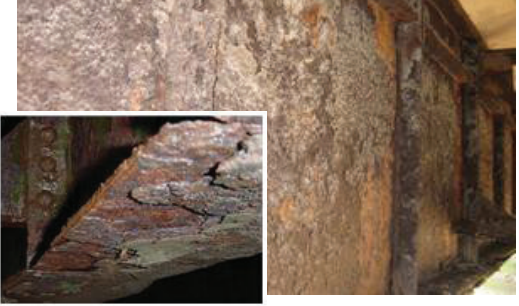
| Damage of Steel Member | Corrosion | 3/5 |
|---|---|---|
| | | Significant reduction in plate thickness has occurred in a wide range of main members. (The required load capacity may already be lost). |

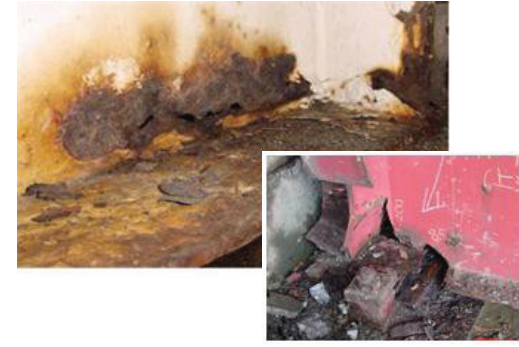
| Damage of Steel Member | Corrosion | 3/5 |
|---|---|---|
| | | Clear cross-section defects have occurred at stress concentration areas such as support areas (There is a possibility of collapse due to large external force such as earthquake). |

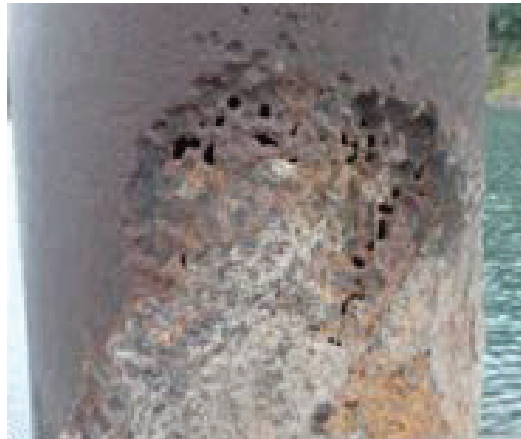
| <div></div> <div>Steel pile-bent piers have corrosion holes and a clear decrease in wall thickness. (It may suddenly buckle due to effects of axial force and bending moment).</div> | | |

| <div><div></div><div><div>The pile-bent pier member in the underwater part may be damaged due to local corrosion, which may make the bridge uneasy with respect to the axial compressive force.</div></div></div> | | |

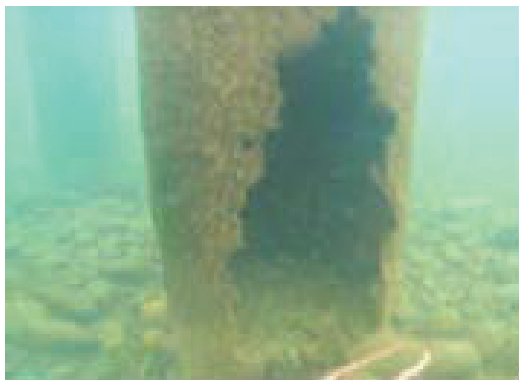
| <div></div> <div>Cross-section loss due to corrosion of steel pile-bent pier. (It may suddenly buckle due to effects of axial force and bending moment).</div> | | |

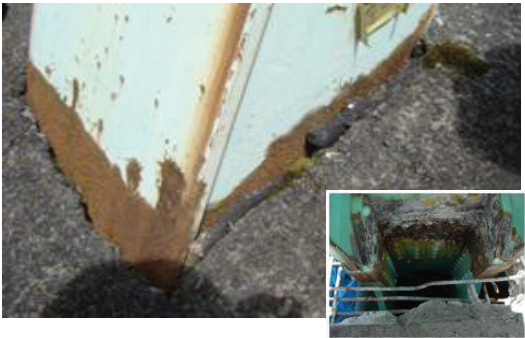
| | | It is suspected that significant corrosion has progressed inside the embedded parts and members which cannot be visually confirmed. (Corrosion may progress inside the embedding part to the point of rupture). |

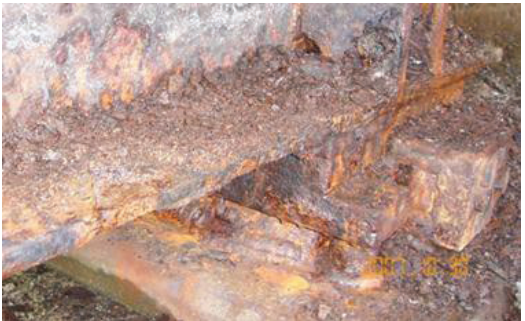
| | | Clear abnormal corrosion is observed in atmospheric corrosion weathering steel. (The impact on load-bearing capacity may not be estimated unless detailed conditions such as thickness measurement are grasped) |

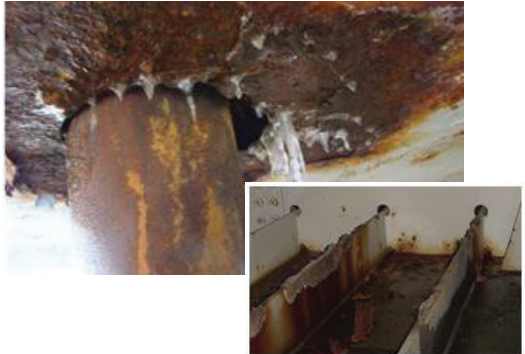
| | | It is suspected that significant corrosion may have occurred due to water retention or water leakage in parts that are not easily visible, such as inside the girder. (Significant corrosion may occur inside the girder, and serious adverse effects may occur). |

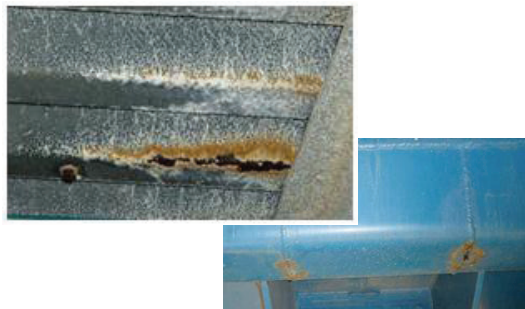
| | | It is suspected that significant corrosion may have progressed inside the parts that cannot be visually observed. (The load bearing capacity of the member may be reduced due to the reduction of the plate thickness from inside). |

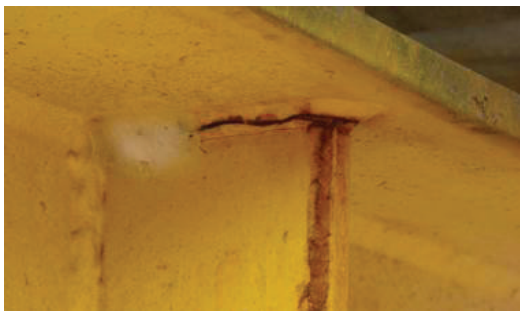
| Damage of Steel Member | Crack | 1/4 |
|---|---|---|
| | Even if it progresses, it is unlikely that the main member will fail immediately, but it is highly possible that damage will continue to progress. | |

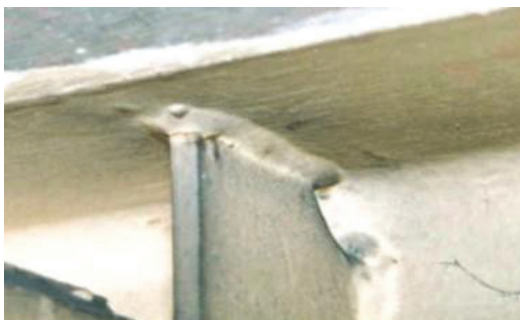
| Damage of Steel Member | Crack | 1/4 |
|---|---|---|
| | Even if it progresses, it is unlikely that the crack will reach the main member immediately, but it is expected that the crack will continue to progress in the future. | |

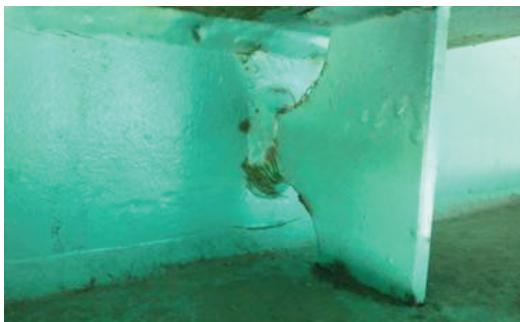
| Damage of Steel Member | Crack | 1/4 |
|---|---|---|
| | Even if it progresses, it is unlikely that the crack will reach the main member immediately, but it is expected that the crack will continue to progress in the future. | |

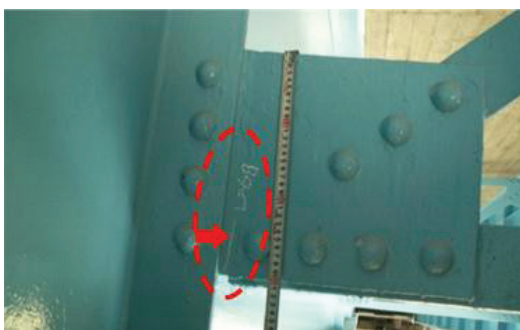
| Damage of Steel Member | Crack | 1/4 |
|---|---|---|
| | Clear cracks occur in the cross frame and the lateral bracing, and the crack propagates from the position and direction, it may not reach the main member immediately, but if left unattended, the member may break. | |

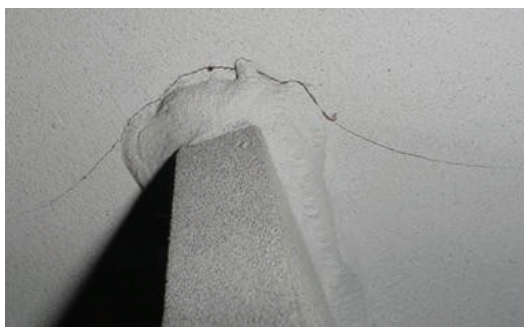
| Damage of Steel Member | Crack | 2/4 |
|---|---|---|
| | A pronounced crack extends to the top of the deck plate, and if it develops further, it is expected to lead to depression and damage to the surfacing. | |

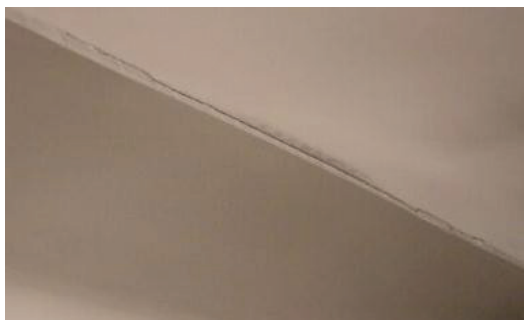
| Damage of Steel Member | Crack | 2/4 |
|---|---|---|
| | A pronounced crack extends to the top of the deck plate, and if it develops further, it is expected to lead to depression and damage to the surfacing. | |

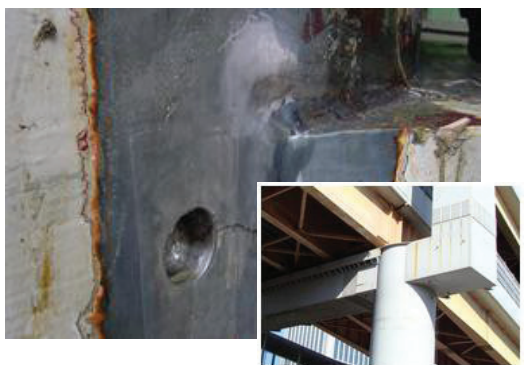
| Damage of Steel Member | Crack | 2/4 |
|---|---|---|
| | Clear cracks have occurred in the corners of the steel pier. Further progress is expected to have serious adverse effects on girders and piers. (Depending on the location, it often progresses to Severity: DL III). | |

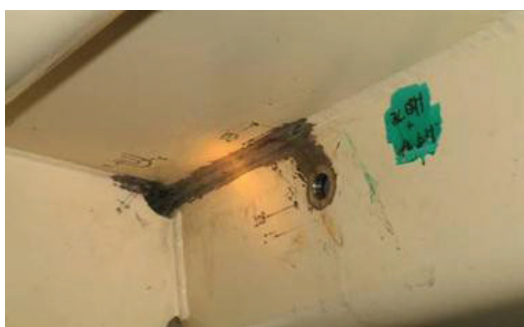
| Damage of Steel Member | Crack | 2/4 |
|---|---|---|
| | Clear cracks extend to the trough ribs of the steel plate, and further propagation is expected to lead to road depression and damage to surfacing. | |

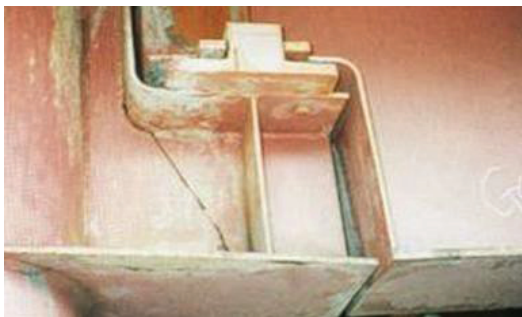
| Damage of Steel Member | Crack | 3/4 |
|---|---|---|
| | Gerber girder plate is cracked regardless of size. | |

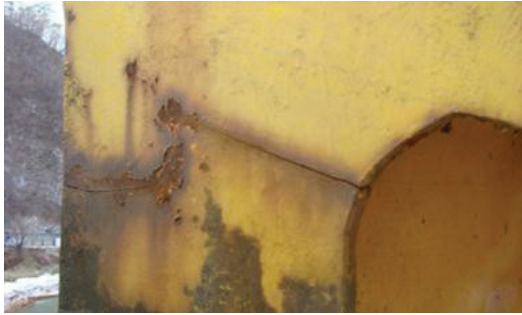
| Damage of Steel Member | Crack | 3/4 |
|---|---|---|
| | Regardless of size, there are obvious cracks in the column members, suspension members, and chord members of arch bridges and truss bridges. | |

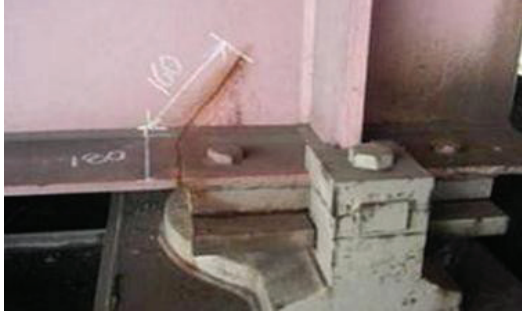
| Damage of Steel Member | Crack | 3/4 |
|---|---|---|
| | There is a clear crack extending from the main girder flange to the web. | |

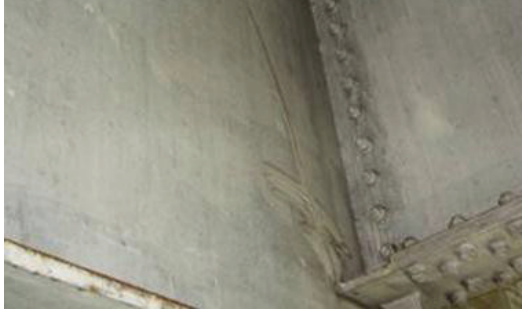
| Damage of Steel Member | Crack | 3/4 |
|---|---|---|
| | Large cracks are growing in the web of main girders and cross girders. | |

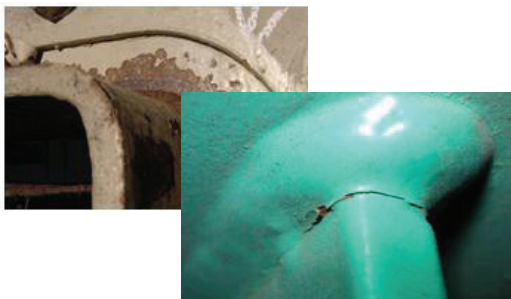
| Damage of Steel Member | Crack | 4/4 |
|---|---|---|
| | Although there is a clear coating film crack near the weld line, the entire crack cannot be confirmed from the appearance. (In order to make a reliable judgment of the presence or absence of cracks, it is necessary to remove the coating film and have a specialist technician grasp the detailed conditions such as non-destructive inspection and shaving.) | |

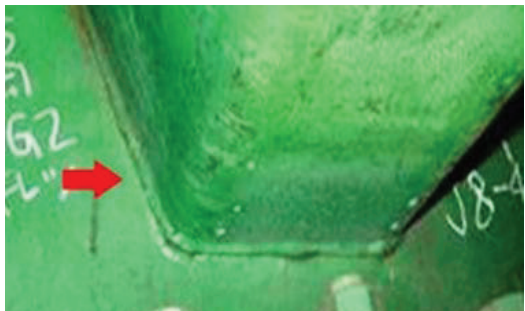
| Damage of Steel Member | Crack | 4/4 |
|---|---|---|
| | Although there are cracks and rusting in the coating that may have serious cracks in the steel plate floor, it cannot be determined only by visual inspection. | |

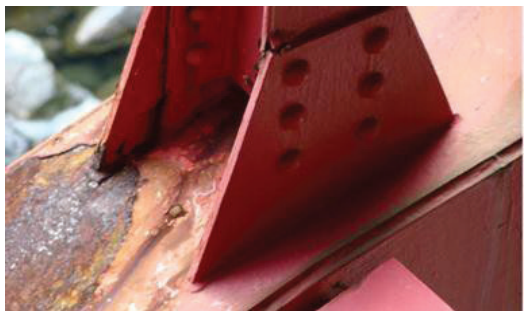
| Damage of Steel Member | Crack | 4/4 |
|---|---|---|
| | There is rust at the lower end of the pillars of the arch bridge, and on the other hand, it is a place where fatigue cracks are prone to occur, so the possibility of fatigue cracks cannot be denied. | |

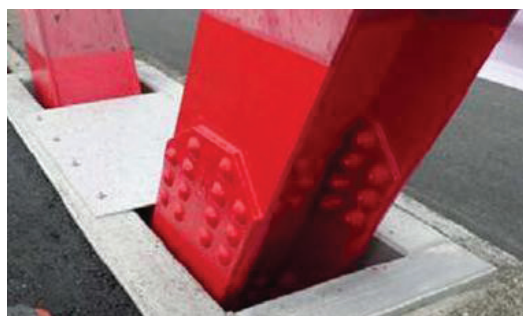
Severity: DL N

The rupture was repaired with a steel plate or other means to restore function, and no new rupture occurs.

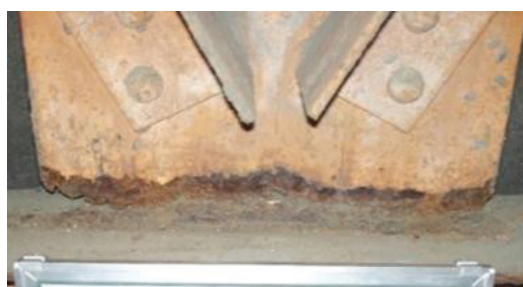
Severity: DL III

Ruptures have occurred in members that have little effect on the load-bearing capacity.

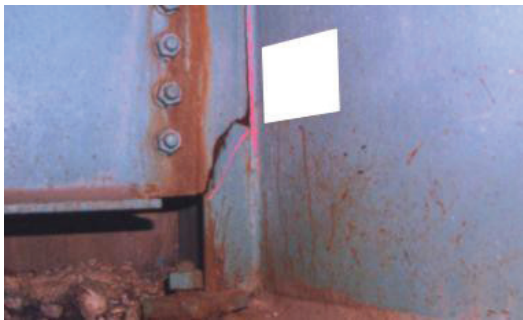
| Damage of Steel Member | Rupture | 2/4 |
|---|---|---|
| | The vertical stiffener at the stress concentration point has broken partially, which may lead to a serious accident such as buckling of the main girder. | |

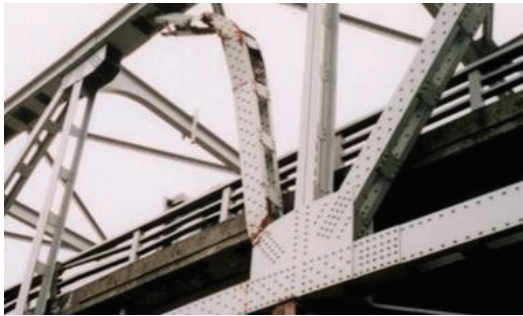
| Damage of Steel Member | Rupture | 2/4 |
|---|---|---|
| | Main members such as diagonal members of truss bridge have been broken, which may lead to collapse of bridge. | |

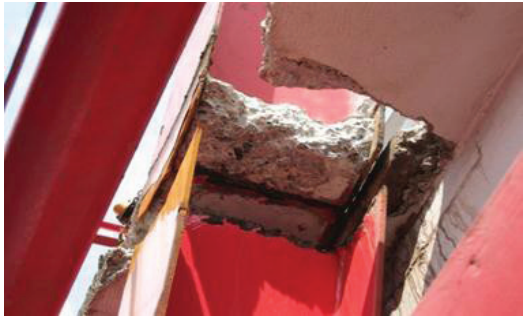
| Damage of Steel Member | Rupture | 2/4 |
|---|---|---|
| | The diagonal material embedded in the floor slab concrete of the truss bridge has been broken, which may lead to the collapse of the bridge. | |

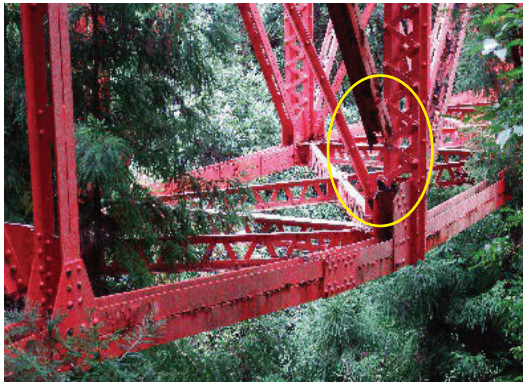
| Damage of Steel Member | Rupture | 2/4 |
|---|---|---|
| | Example of rupture in part of truss bridge diagonal member. | |

| Damage of Steel Member | Rupture | 2/4 |
|---|---|---|
| <ul style="list-style-type: none"><li>The breakage of main member generally has a serious adverse effect not only on the damage of the member but also on the structural safety of the entire bridge.</li></ul> | | |

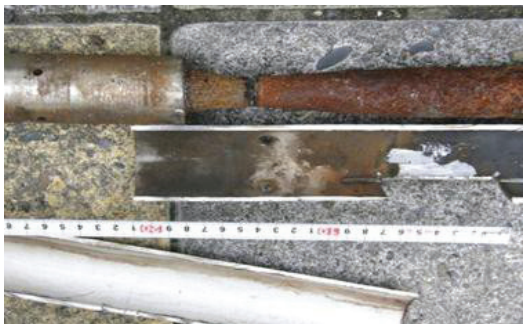
| | | A part of the suspension material of the arch bridge has ruptured due to corrosion, and it is suspected that other suspension materials under the same conditions are also progressing. |

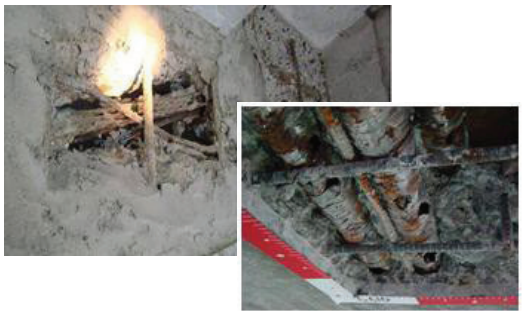
| | | PC steel materials have ruptured due to the progress of corrosion, and it is suspected that similar corrosion also occurs at other places. |

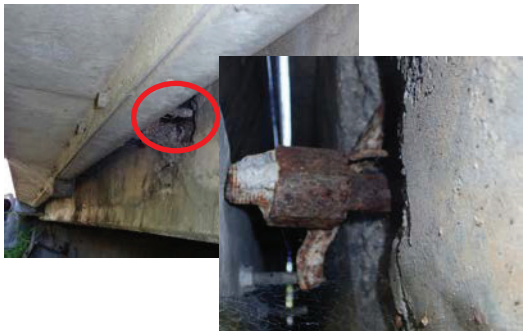
| | | PC steel material is protruding and colliding with the mounted facility. |

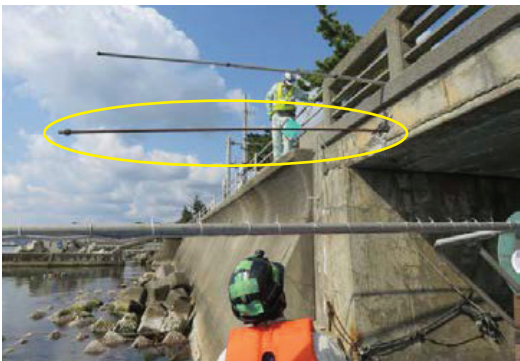
| | | PC steel material ruptures and protrudes. (Similar damage may progress in other PC steel materials). |

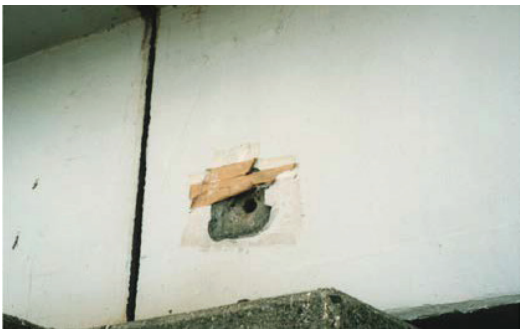
| | | Concrete at the PC steel anchorage part for pre-stressing of cross beam has peeled off, and PC steel has also come out. (Similar damage may progress in other PC steel materials). |

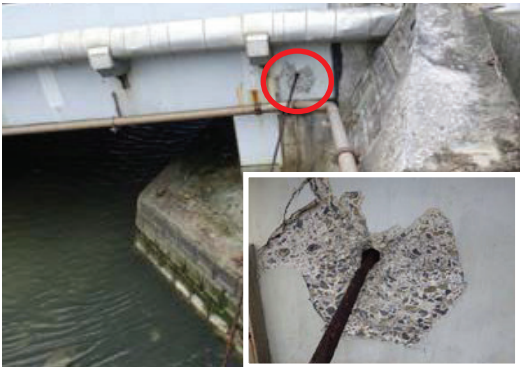
| | | PC steel material breaks and is protruding. (Similar damage may progress in other PC steel materials). |

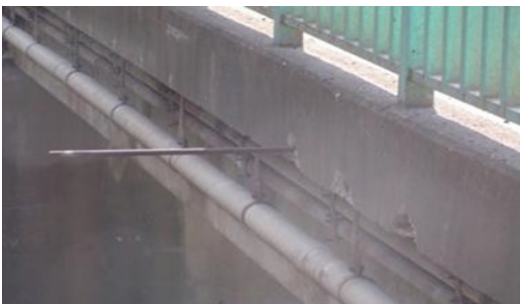
| | | PC steel material has ruptured, and it is suspected that other PC steel materials have deteriorated and that the deterioration of members is due to the infiltration of rainwater into the PC girders. |

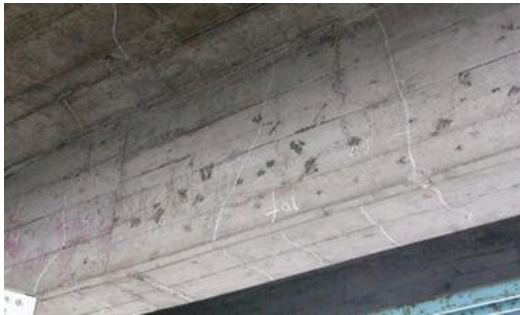
| Damage of Concrete Member | Crack | 1/6 |
|---|---|---|
| | <p>There is a crack that can be easily seen by close-up visual observation, but it is unlikely to progress if for example:</p> <p>Position where the stress does not change repeatedly or is small</p> <p>Position/property that is considered to be low or not likely to cause corrosion of internal steel due to infiltration of rainwater</p> | |

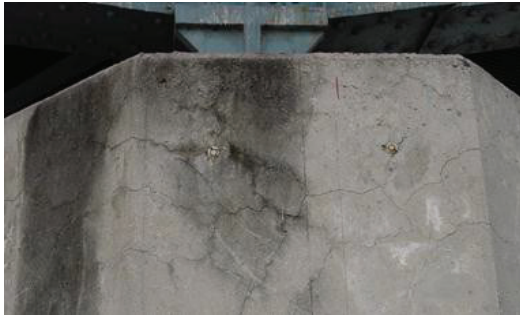
| Damage of Concrete Member | Crack | 1/6 |
|---|---|---|
| | <p>There is a noticeable crack that can be easily visually recognized, and if left unattended, deterioration is expected to progress steadily due to infiltration of rainwater into the interior.</p> | |

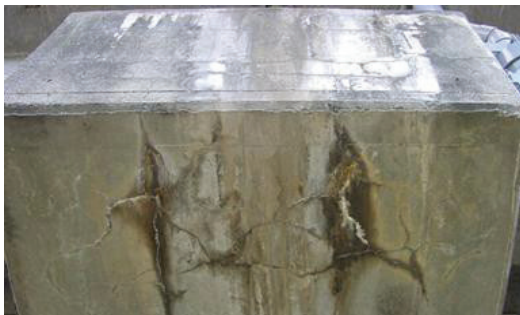
| Damage of Concrete Member | Crack | 1/6 |
|---|---|---|
| | <p>There is a noticeable crack that can be easily visually recognized, and if left unattended, it is expected that the deterioration will certainly progress due to infiltration of rainwater into the interior.</p> | |

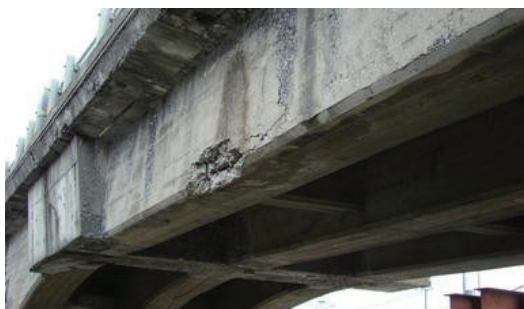
| Damage of Concrete Member | Crack | 2/6 |
|---|---|---|
| | There is a crack that can be easily seen by close-up visual inspection, and the corrosion of internal reinforcing bars and PC steel material is progressing. | |

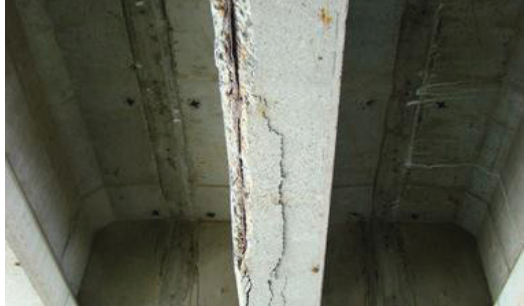
| Damage of Concrete Member | Crack | 2/6 |
|---|---|---|
| | A large number of cracks on the girder, concrete spalling and exposed rebars have occurred, and corrosion of the reinforcement bars has progressed extensively. | |

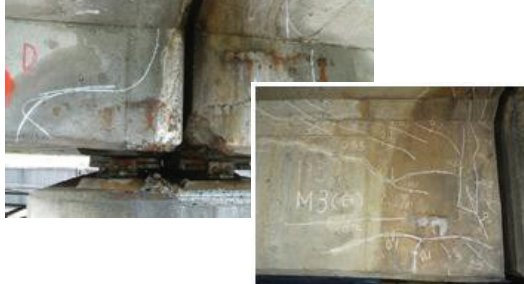
| Damage of Concrete Member | Crack | 2/6 |
|---|---|---|
| | There are many remarkable cracks in the anchorages at the girder ends of PC bridges, which may indicate corrosion of internal steel. | |

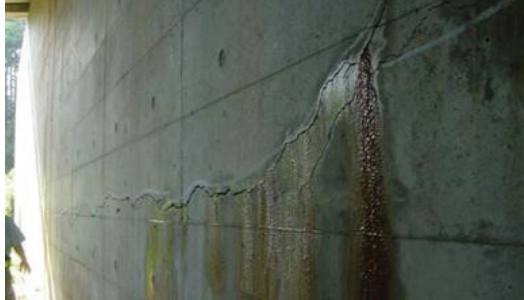
| Damage of Concrete Member | Crack | 2/6 |
|---|---|---|
| | There is a crack that can be easily seen by close-up visual inspection, and it is expected that deterioration will progress rapidly due to continued significant water leakage. | |

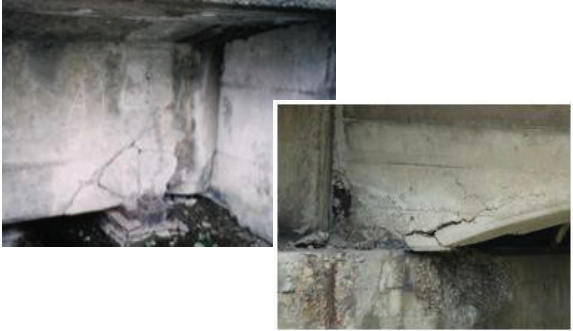
| Damage of Concrete Member | Crack | 3/6 |
|---|---|---|
| | | Significant cracks have occurred near the supporting point of the main girder, and the function of the bearing is also significantly reduced. |

| Damage of Concrete Member | Crack | 3/6 |
|---|---|---|
| <ul style="list-style-type: none"> <li>If the cause of the crack or the adverse effect on the member cannot be easily determined, it is necessary to grasp the detailed condition.</li> </ul> | | |

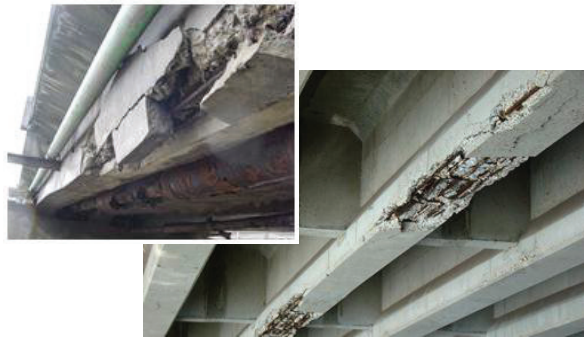
| Damage of Concrete Member | Crack | 3/6 |
|---|---|---|
| | | Many cracks have occurred in the main members, and it is considered that the reinforcement bars have ruptured at various places. |

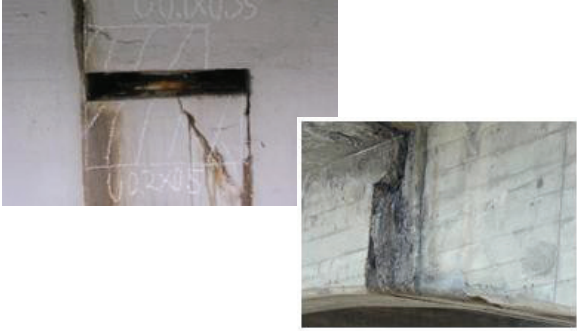
| Damage of Concrete Member | Crack | 3/6 |
|---|---|---|
| | | Significant cracks have occurred in the parts such as the receiving beams of the main members, whose destruction directly causes the collapse of the bridge. |

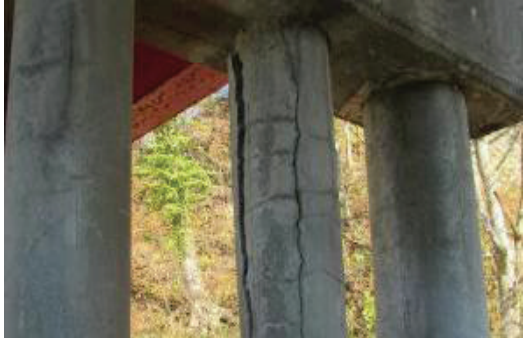
| Damage of Concrete Member | Crack | 4/6 |
|---|---|---|
| | | The pile-bent type bridge pier is significantly cracked in the axial direction, and it is suspected that the pile-bent may be destroyed due to the effect of eccentric load, and the bridge may fall down. |

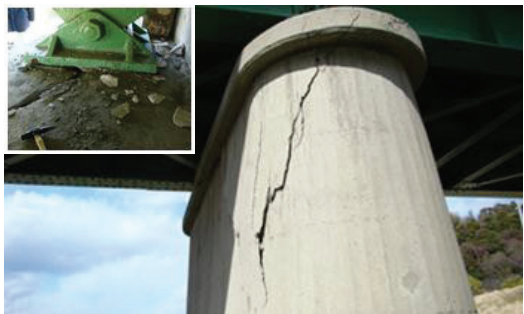
| Damage of Concrete Member | Crack | 4/6 |
|---|---|---|
| | | The beams and columns of the substructure are markedly cracked, and it is suspected that the bridge may collapse if it progresses. |

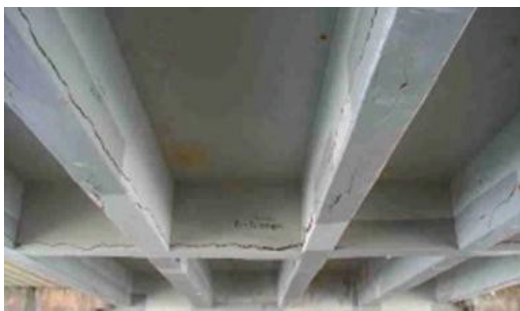
| Damage of Concrete Member | Crack | 5/6 |
|---|---|---|
| | <p>Cracks have developed from parts that have been repaired or reinforced in the past, and it is considered necessary to investigate the cause. In the case of cracks caused by re-deterioration, it is often impossible to determine the entire appearance of the deformation by visual inspection, and if deterioration is progressing internally, it may be in a dangerous state.</p> | |

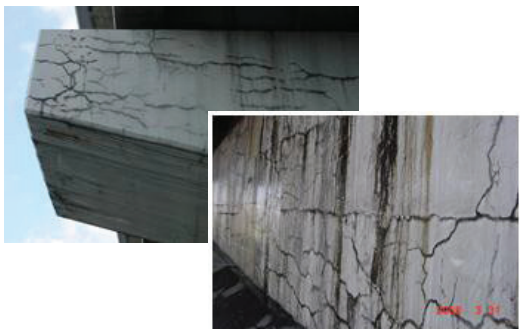
| Damage of Concrete Member | Crack | 5/6 |
|---|---|---|
| | <p>Cracks have developed from parts that have been repaired or reinforced in the past, and it is considered necessary to investigate the cause. (In the case of cracks caused by re-deterioration, it is often impossible to determine the entire appearance of the deformation by visual inspection, and if deterioration is progressing internally, it may be in a dangerous state).</p> | |

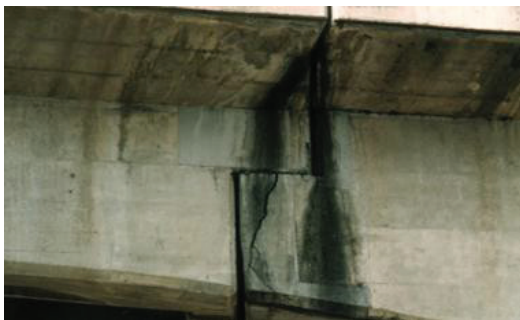
| Damage of Concrete Member | Crack | 5/6 |
|---|---|---|
| | <p>When cracks develop in the main member, it is difficult to determine whether the serious adverse impact on load bearing capacity is undeniable by only visual inspection.</p> <p>For example:</p> <ul style="list-style-type: none"><li>• Support area of Gerber/cantilever hinged bridge structure</li><li>• Area which supports bearing capacity of bearing</li><li>• Shear crack</li></ul> | |

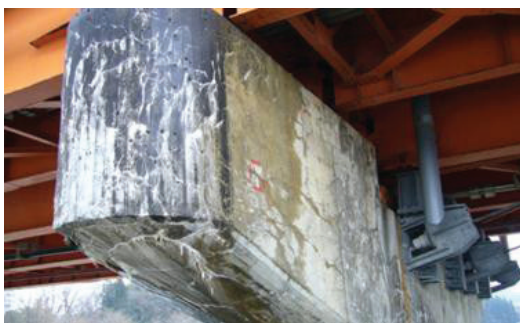
| Damage of Concrete Member | Crack | 5/6 |
|---|---|---|
| | <p>Suspected to be caused by salt damage or alkali-silica reaction.</p> | |

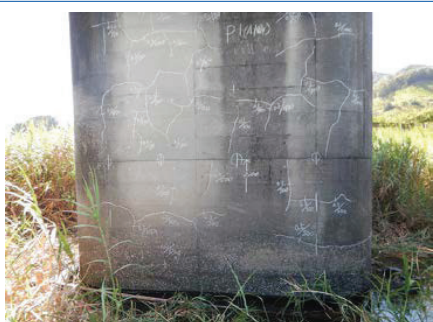
| Damage of Concrete Member | Crack | 6/6 |
|---|---|---|
| | Although there is no noticeable free lime, it is cracked irregularly in two directions. (If aggregate pop-out is observed, it is suspected that an alkali-silica reaction has occurred). | |

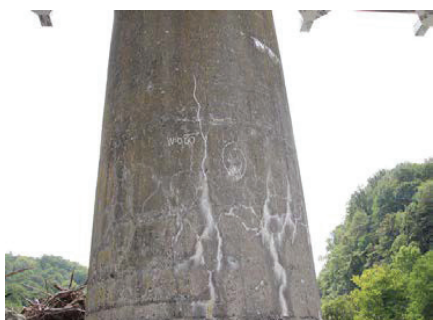
| Damage of Concrete Member | Crack | 6/6 |
|---|---|---|
| | Situation suspected of causing salt damage or alkali-silica reaction. | |

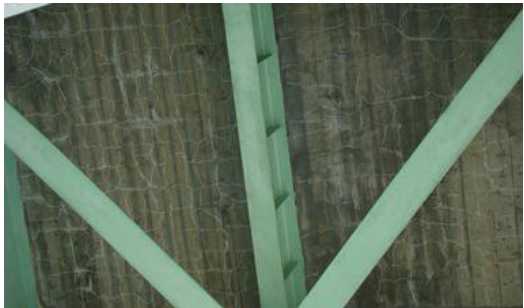
| Damage of Concrete Member | Slab Crack | 1/5 |
|---|---|---|
| | | There is no noticeable water leakage, but extensive cracks in a grid pattern develop throughout the concrete slab. |

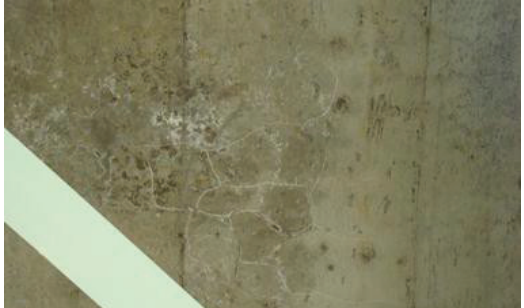
| Damage of Concrete Member | Slab Crack | 1/5 |
|---|---|---|
| | | There are relatively few cracks, but there are clear penetrating cracks (water leakage, precipitation of lime). |

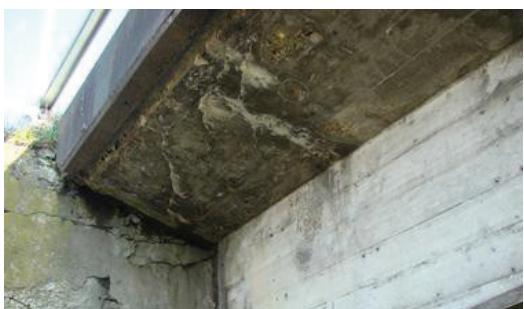
| Damage of Concrete Member | Slab Crack | 1/5 |
|---|---|---|
| | | Rainwater is significantly infiltrating the concrete slab, and it is expected that deterioration will progress rapidly if left unattended. |

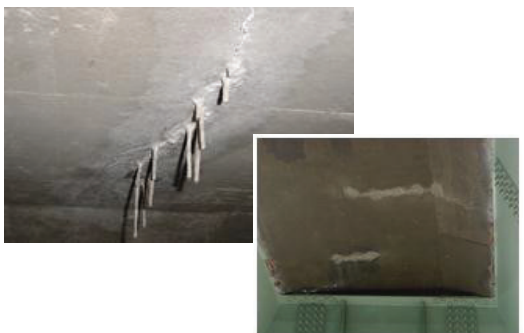
| Damage of Concrete Member | Slab Crack | 1/5 |
|---|---|---|
| | | There are relatively few cracks, but there are clear penetrating cracks (water leakage, precipitation of lime). |

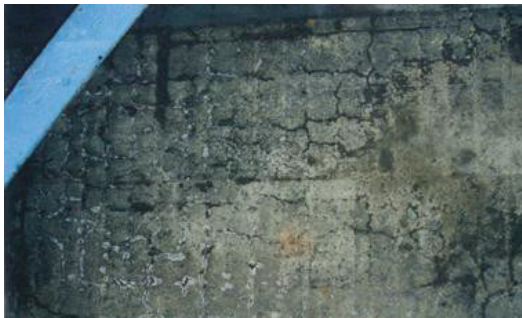
| Damage of Concrete Member | Slab Crack | 2/5 |
|---|---|---|
| | There is a densely developed grid-like cracks with water leakage. Or there is a large area with concentrated wet cracks on the bottom surface of the concrete slab. | |

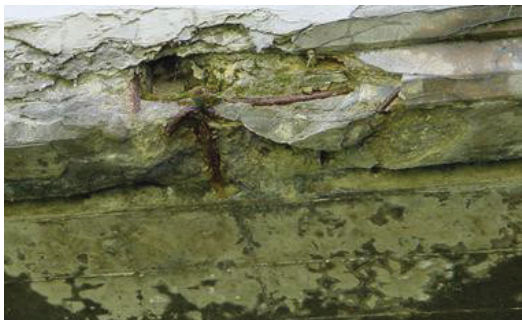
| Damage of Concrete Member | Slab Crack | 2/5 |
|---|---|---|
| | Rainwater has penetrated into the concrete slab, and the corrosion of steel bars is widespread. | |

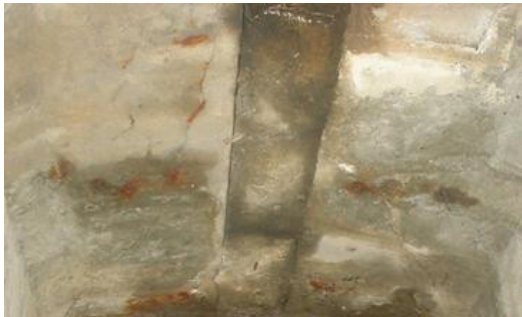
| Damage of Concrete Member | Slab Crack | 2/5 |
|---|---|---|
| | Significant cracks occur in the filling concrete part. (The filled concrete part may fall off). | |

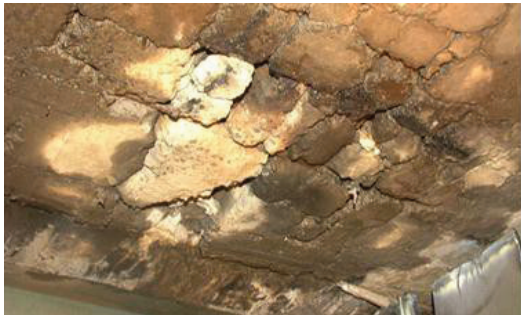
| Damage of Concrete Member | Slab Crack | 3/5 |
|---|---|---|
| | | In the case that the concrete slab loses its integrity in a certain area, it may easily fall out due to the action of wheel load. |

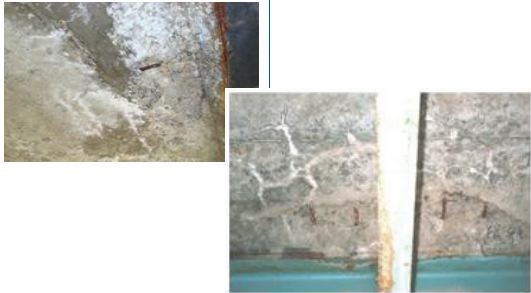
| Damage of Concrete Member | Slab Crack | 3/5 |
|---|---|---|
| | | The concrete slab is cracked with noticeable water leakage, and there is obvious spalling or peeling on the bottom surface of the concrete slab. |

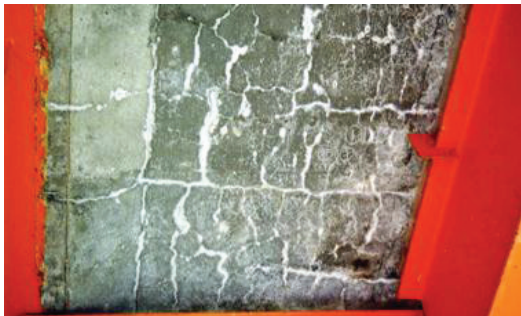
| Damage of Concrete Member | Slab Crack | 3/5 |
|---|---|---|
| | | Densely developed grid-like cracks with pronounced water leakage. |

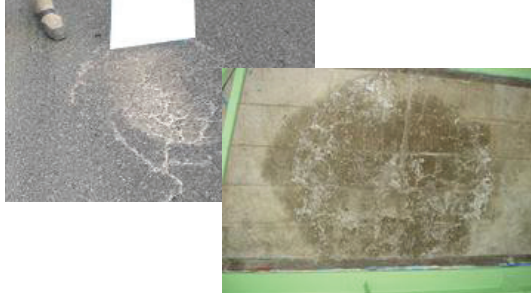
| Damage of Concrete Member | Slab Crack | 3/5 |
|---|---|---|
| | | Development of white color cracks with lime deposits and discoloration due to infiltration spread on part of the bottom surface of the slab. (If the surfacing on the concrete slab shows a dent or a slag of cement, it is likely that the top surface of the concrete slab has turned into granulation). |

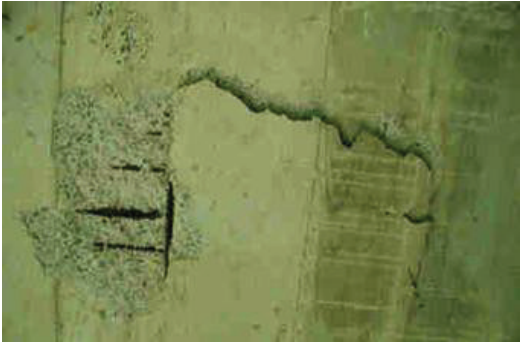
| | | If there is significant spalling, peeling, or exposed reinforcing bars on the bottom surface of the concrete slab, deterioration may have progressed inside the slab. |

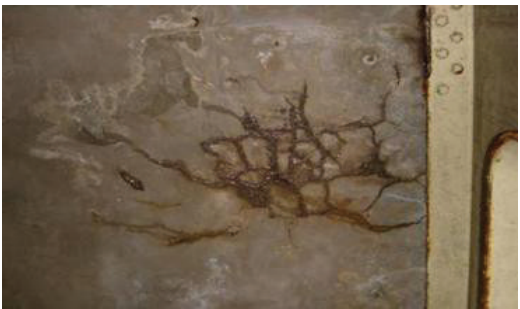
| | | Part of the concrete slab shows unusual discoloration and water leakage |

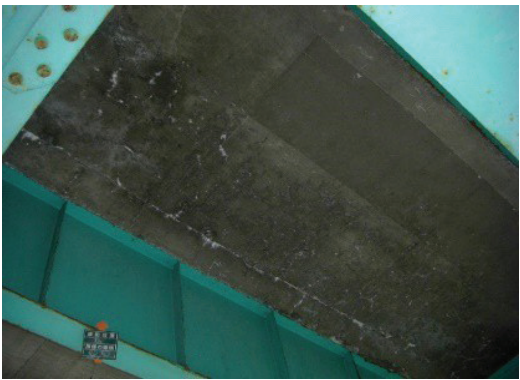
| | | Although no grid-like cracks with remarkable water leakage appeared, it was suspected that water retention had spread inside the concrete due to the spread of significant discoloration on the entire surface of the slab. |

| <ul style="list-style-type: none"> <li>If the salt damage or alkali-aggregate reaction becomes serious, repair and reinforcement may become difficult and it may be necessary to re-construction. It is necessary for an expert to grasp the condition and prepare a maintenance plan.</li> <li>If cracks are not noticeable but water stains and lime deposits are widely spread, horizontal cracks may have spread inside the concrete.</li> </ul> | | |

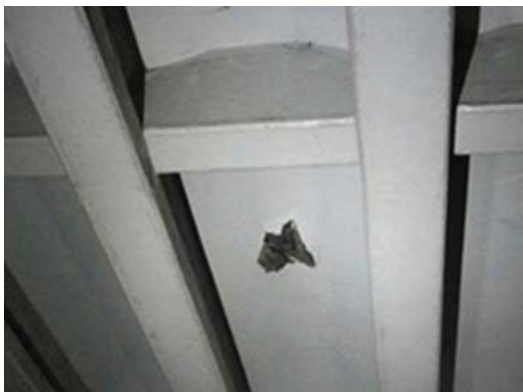
| | | There is concern about falling out of the infill concrete (the photo shows an example of falling out). |

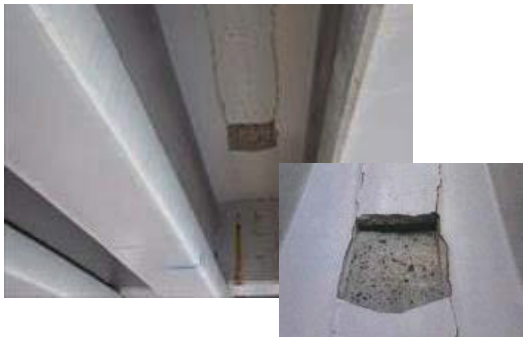
| | | There is concern about falling out of the infill concrete (the photo shows an example of falling out). |

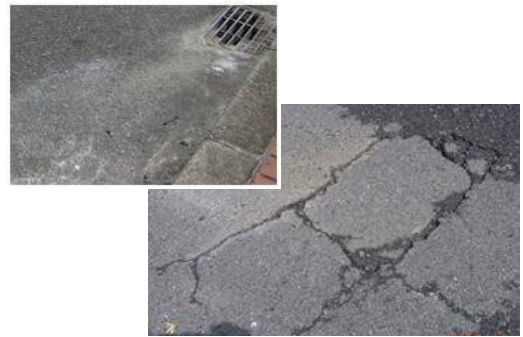
| | | Characteristic cracks and white discoloration on the surface. (The concrete slab under the surfacing may be significantly damaged). |

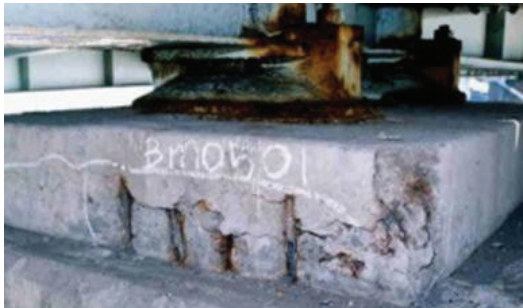
| Others | Damage of Bearing | 1/4 |
|---|---|---|
| | The paint on the bearing has deteriorated, causing the base concrete to be chipped. It is expected that deterioration will progress if left unattended and it will be difficult to maintain the bearing function even if repaired. | |

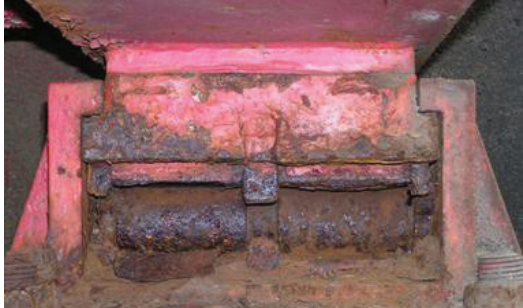
| Others | Damage of Bearing | 1/4 |
|---|---|---|
| | Corrosion is found in the bearing body, the bearing function is reduced, and it is considered that the function will be rapidly lost if left unattended. | |

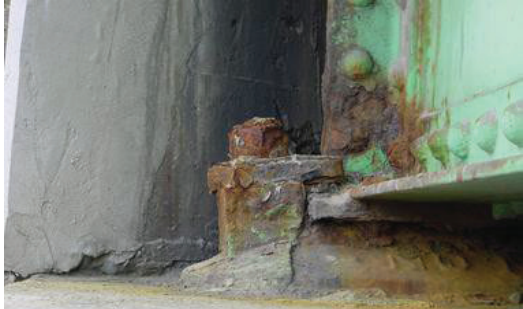
| Others | Damage of Bearing | 1/4 |
|---|---|---|
| | If the anticorrosion function of the bearing is significantly reduced and corrosion is progressing on the whole, it is expected that it will be difficult to recover its function rapidly if left unattended. | |

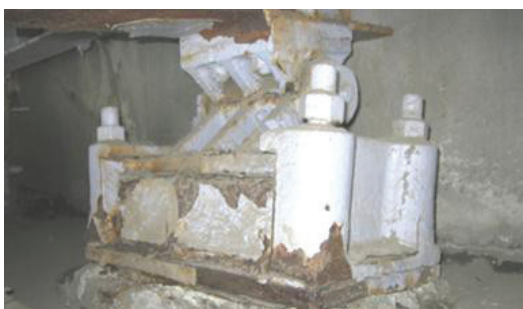
| Others | Damage of Bearing | 1/4 |
|---|---|---|
| | Corrosion is progressing and bolts are loosening. If left untreated, the performance is expected to decline steadily due to the further progress of corrosion and other natural causes. | |

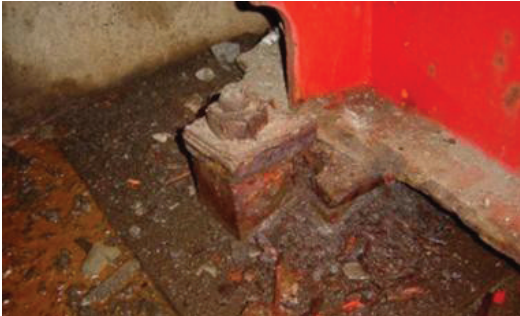
| | | In the case that the entire main body of the bearing is significantly corroded and the thickness of the bearing is also being reduced, if the corrosion continues as it is, the load bearing capacity may be reduced, which may cause a serious disaster such as dropping of the girder. |

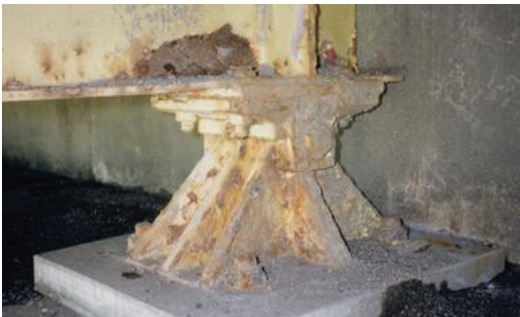
| | | Regarding the bearing and the main girder that attaches it, significant corrosion with a decrease in plate thickness is progressing. |

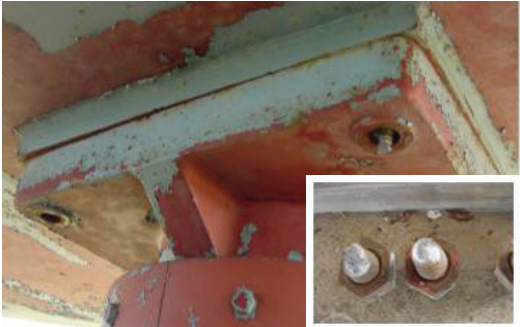
| | | The mounting bolt of the bearing is broken and the support function is deteriorated. If a large external force such as an earthquake occurs, it may not be possible to satisfy the required functions. |

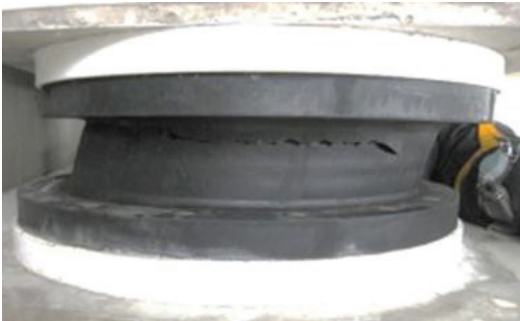
| | | The rubber bearing body has noticeable cracks. If a large external force such as an earthquake occurs, it may not be possible to satisfy the required functions. |

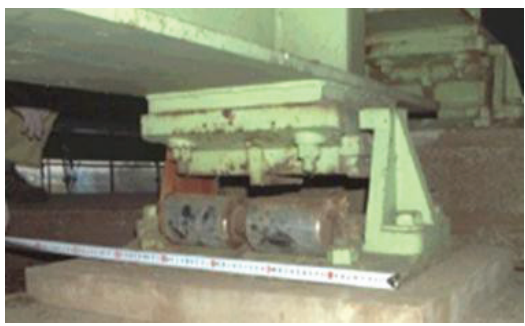
| Others | Damage of Bearing | 3/4 |
|---|---|---|
| | | If the load bearing function of the bearing is lost, such as the fall off of a roller of the bearing, there is a possibility of a dangerous state due to a step or girder fall down. |

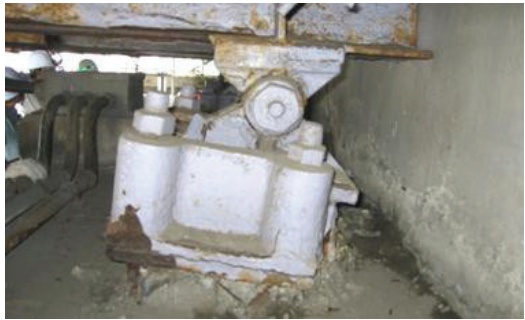
| Others | Damage of Bearing | 3/4 |
|---|---|---|
| | | If it is recognized that the load bearing capacity of the bearing is greatly reduced due to the damage of the pedestal mortar, there is a possibility that it will be in a dangerous state due to a step or the girder falling off. |

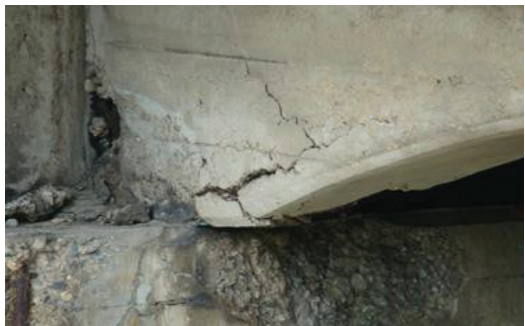
| Others | Damage of Bearing | 3/4 |
|---|---|---|
| | | The bearing part, the girder of its mounting part, and the substructure main body are severely damaged.<br><br>(The function of the bearing is lost, and it may lead to a bridge collapse). |

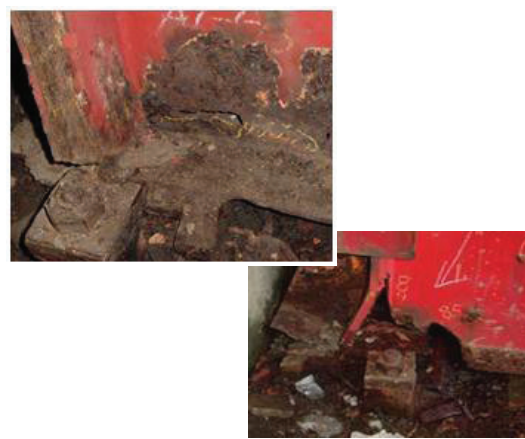
| Others | Damage of Bearing | 3/4 |
|---|---|---|
| | | If the bearing and its attachment to the main girder have a significant section loss, the girder ends may collapse due to the influence of wheel load or a small/medium-sized earthquake. |

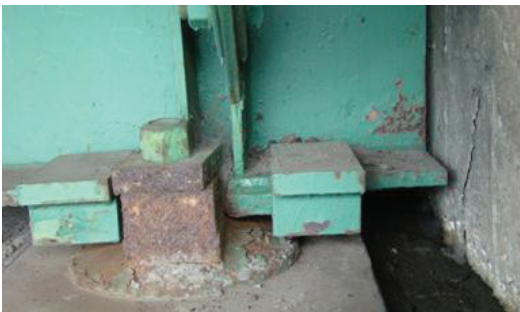
| | | Abnormalities are found in the gap between the bearing and the end of the girder, so it is necessary to investigate the cause. |

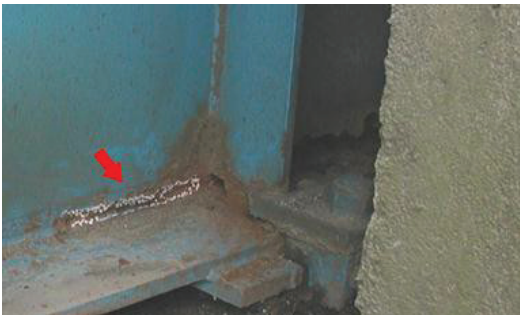
| | | Corrosion has spread to the vicinity of the bearing, and it is suspected that cracks will soon begin to occur. |

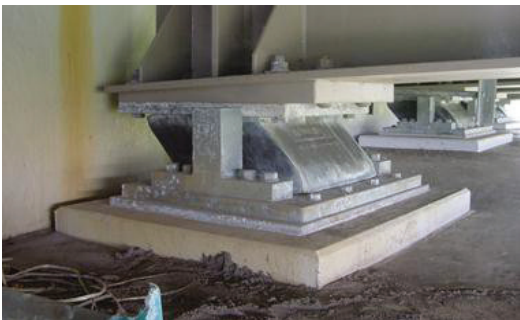
| | | Suspected damage to the bearing body due to abnormal residual displacement after an earthquake. |

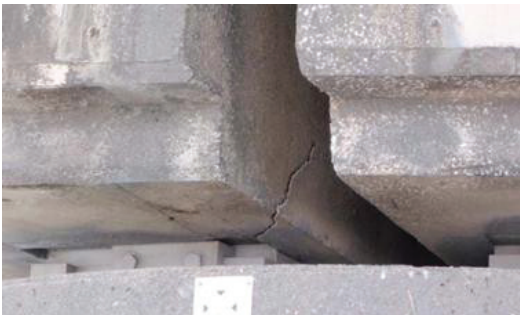
| | | Damage of bearing mounting part may affect bearing function, so load bearing capacity needs to be evaluated. |
