# BRIDGE INSPECTION MANUAL

FOR ARBICS AND PBC

The Project for Strengthening of Capacity Development on  
Bridge Management System in the Republic of Kenya

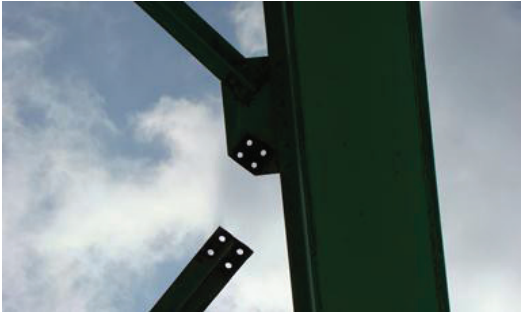
| Others | Looseness and Loss of Bolts | Steel |
|---|---|---|
| | | Bolts are falling out. (The bolts may break due to a large external force). |

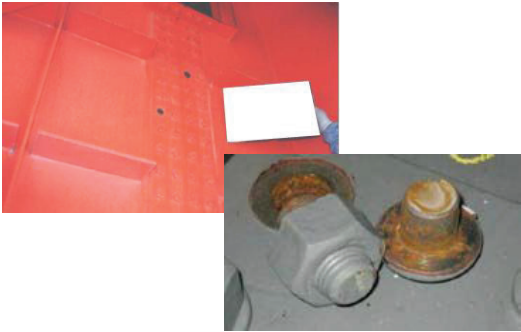
| Others | Looseness and Loss of Bolts | Steel |
|---|---|---|
| | | Some high strength bolts are missing. |

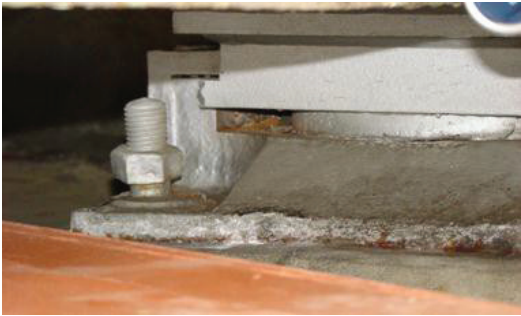
| Others | Looseness and Loss of Bolts | Steel |
|---|---|---|
| | | Loose anchor bolts and mounting bolts. |

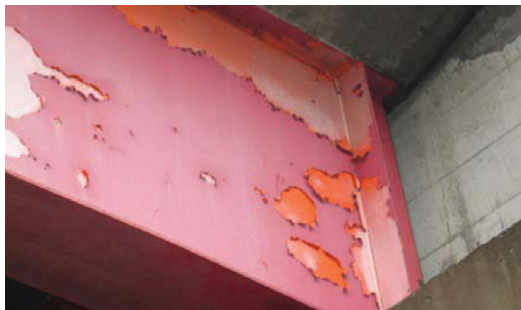
| Others | Deterioration of Anticorrosion Function | Common |
|---|---|---|
| | No rusting, but noticeable deterioration in topcoat. | |

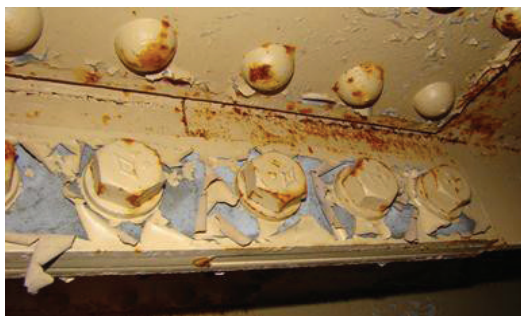
| Others | Deterioration of Anticorrosion Function | Common |
|---|---|---|
| | Although the rust has not spread, the deterioration of the coating film is progressing and the undercoat paint is exposed.. | |

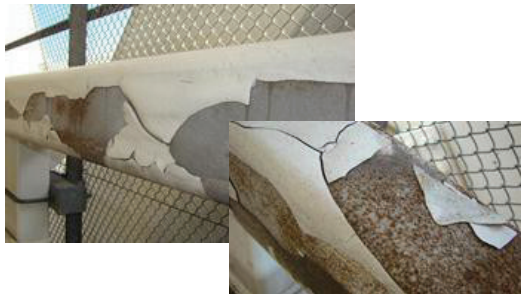
| Others | Deterioration of Anticorrosion Function | Common |
|---|---|---|
| | Deterioration of the plating and coating surface.. | |

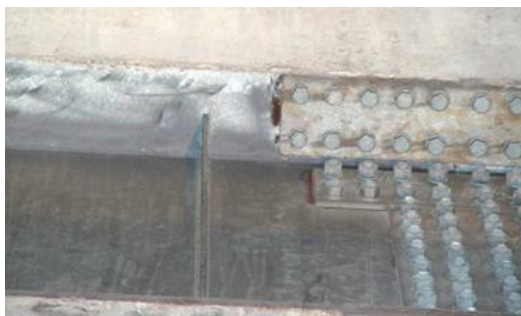
| Others | Deterioration of Anticorrosion Function | Common |
|---|---|---|
| | Rust on the surface of plated steel member.. | |

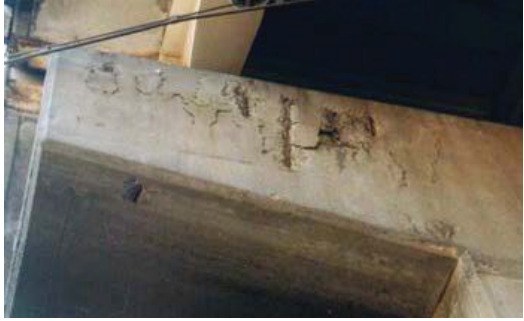
| Others | Spalling, Peeling, Rebar Exposure | Concrete |
|---|---|---|
| | Concrete member with peeling and reinforcing bar exposed. (Concrete pieces may fall). | |

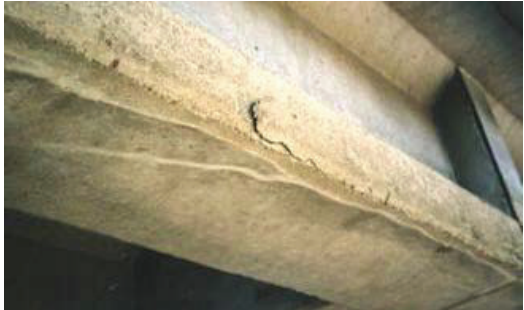
| Others | Spalling, Peeling, Rebar Exposure | Concrete |
|---|---|---|
| | Concrete member with spalling and/or peeling. (Corrosion of steel may progress internally). | |

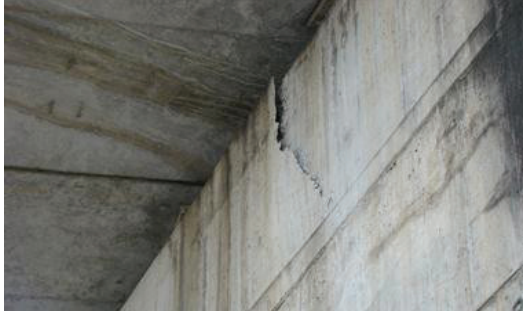
| Others | Spalling, Peeling, Rebar Exposure | Concrete |
|---|---|---|
| | Concrete member with spalling and/or peeling. (Cracks are progressing inside the member due to a large external force). | |

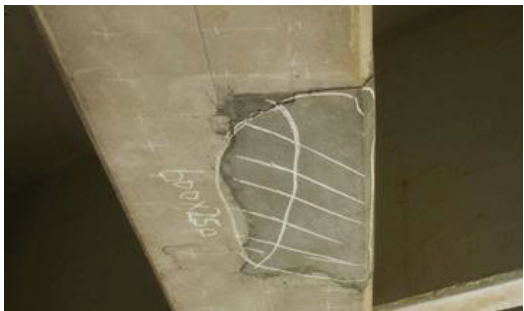
| Others | Spalling, Peeling, Rebar Exposure | Concrete |
|---|---|---|
| | Concrete member with spalling and/or peeling. (Re-deterioration of the repaired part may cause spalling and/or peeling). | |

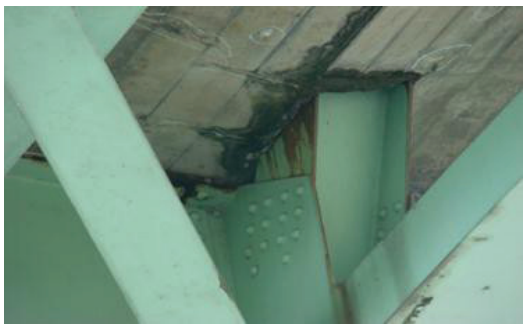
| Others | Water Leakage/Free Lime | Concrete |
|---|---|---|
| | Water leakage around the steel member embedded in the concrete part. (May be significantly corroded inside the embedded part). | |

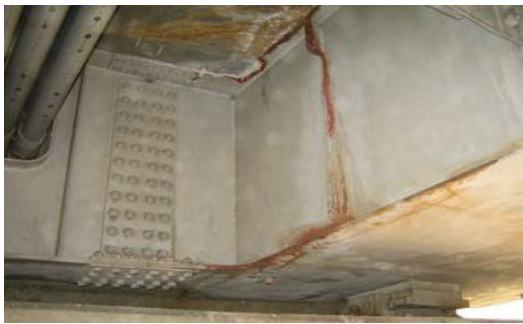
| Others | Water Leakage/Free Lime | Concrete |
|---|---|---|
| | Water leakage from the concrete slab. (If water leakage continues from the same location due to through cracks or the like, local deterioration may become apparent). | |

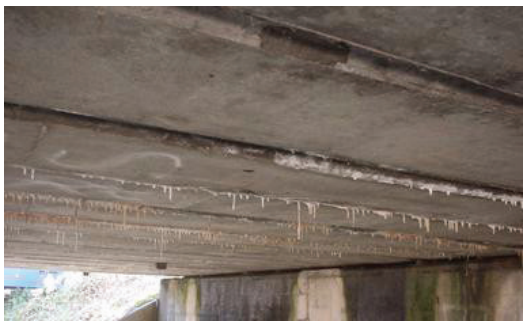
| Others | Water Leakage/Free Lime | Concrete |
|---|---|---|
| | Water leakage from the boundary between girder members. (The infill may deteriorate, or rainwater may penetrate into the parts and deteriorate the parts). (There may be corrosion of laterally tightened PC steel material that crosses the girders). | |

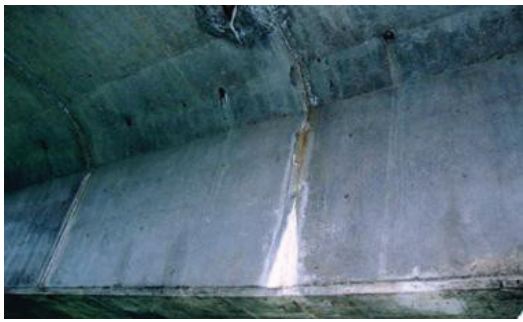
| Others | Water Leakage/Free Lime | Concrete |
|---|---|---|
| | Water leakage and free lime precipitation from the joint of the precast member. (Corrosion of the PC steel materials and reinforcing bars between/in the concrete members may occur, and/or corrosion may spread inside the concrete members along the steel materials). | |

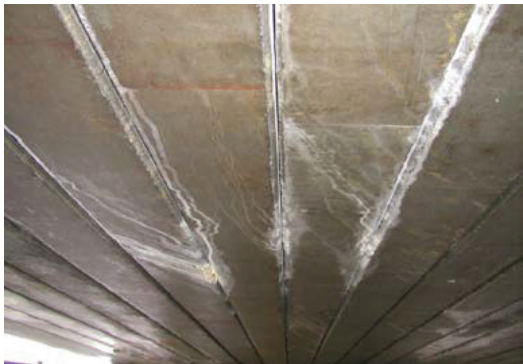
| Others | Water Leakage/Free Lime | Concrete |
|---|---|---|
| | | Precipitation of free lime has occurred from the infill of the precast hollow slab bridge. (The horizontally tightened PC steel material may have deteriorated due to infiltration of rainwater, etc.). |

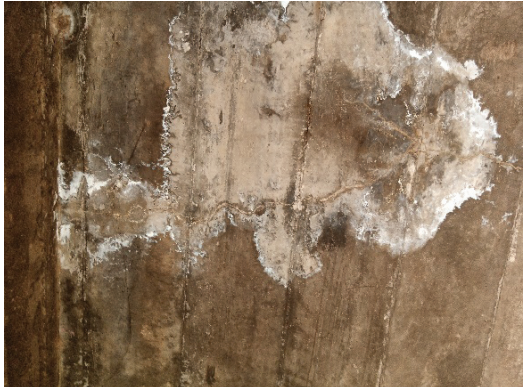
| Others | Water Leakage/Free Lime | Concrete |
|---|---|---|
| | | Precipitation of free lime has occurred from a crack on the slab. (Corrosion of the PC steel materials and reinforcing bars between/in the concrete members may occur, and/or corrosion may spread inside the concrete members along the steel materials). |

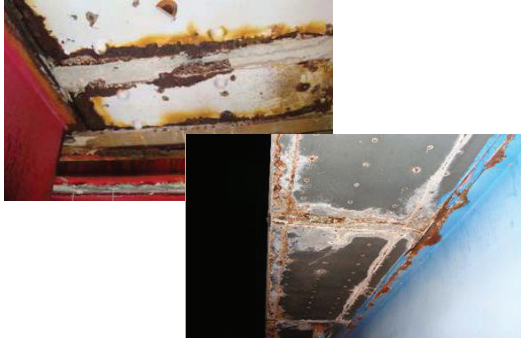
| Others | Damage of Reinforced Members | Concrete |
|---|---|---|
| | | Corrosion is suspected on the reinforced steel plate on the back of the concrete slab, which is suspected of permeating rainwater into the slab. (The deterioration of the concrete slab may progress inside, and it may fall out suddenly). |

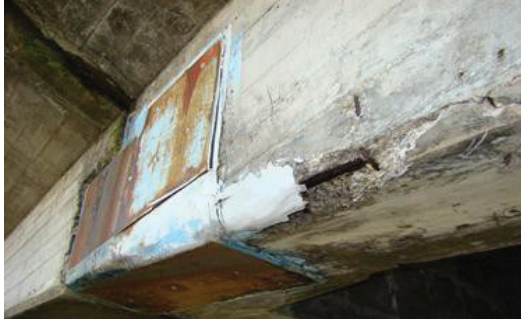
| Others | Damage of Reinforced Members | Concrete |
|---|---|---|
| | | Re-deterioration (corrosion, spalling) of reinforcing member (steel plate) is observed. (Reinforcement effect may be lost or deterioration may have progressed inside the reinforcement member). |

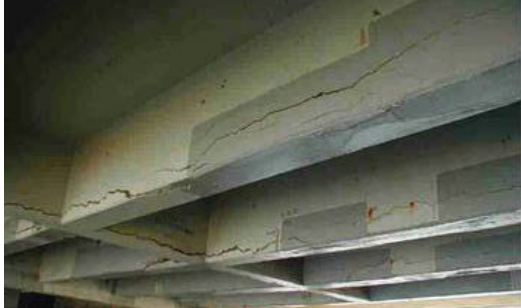
| Others | Damage of Reinforced Members | Concrete |
|---|---|---|
| | | Re-deterioration of repaired member (surface protection work) is observed. In this example, the concrete girder is also cracked, and the crack on the concrete is evaluated. |

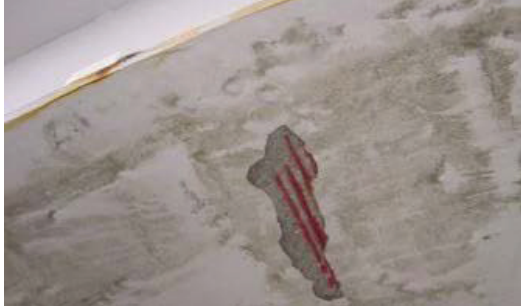
| Others | Damage of Reinforced Members | Concrete |
|---|---|---|
| | | In case further deterioration of the repaired member is observed, it is possible that damage could be progressing on the inside without visible signs from the outside. |

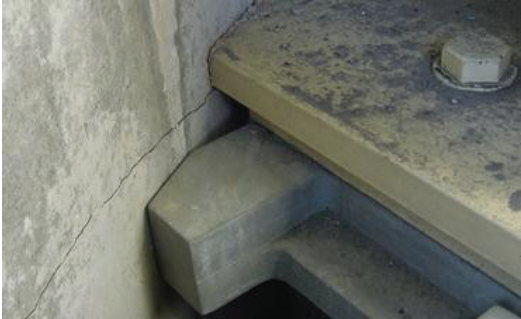
| Others | Gap Error at the Girder-End | Common |
|---|---|---|
| | | The girder-end is in contact with the substructure. (The substructure may be displaced). |

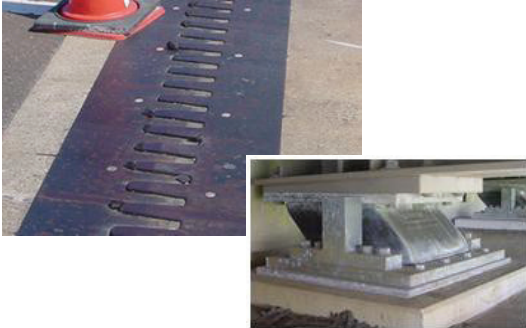
| Others | Gap Error at the Girder-End | Common |
|---|---|---|
| | | Spacing between expansion joint devices is abnormally narrow. (The substructure may be displaced due to natural occurrences). |

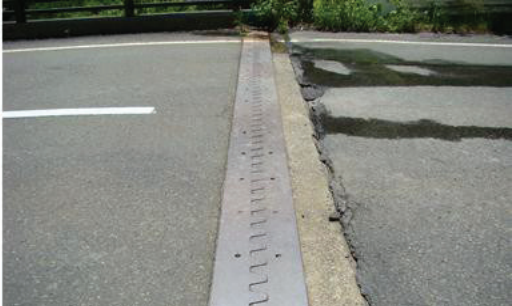
| Others | Gap Error at the Girder-End | Common |
|---|---|---|
| | | Spacing between expansion joint devices is abnormally narrow. (The substructure may be displaced due to the influence of an earthquake or other natural occurrences). |

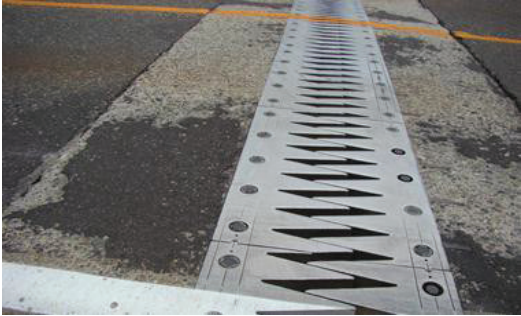
| Others | Gap Error at the Girder-End | Common |
|---|---|---|
| | | The expansion joint devices are not evenly spaced (in the direction perpendicular to the bridge axis).<br><br>(In addition to the displacement of the substructure due to the impact of the earthquake, abnormal horizontal displacement may occur between superstructure and substructure due to abnormalities in the superstructure and damage to the bearings). |

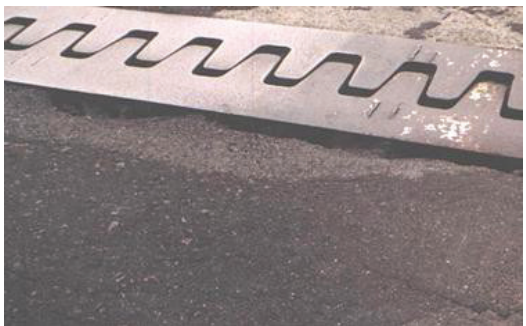
| Others | Irregularities of Road Surface | Road Surface |
|---|---|---|
| | Irregularities at the boundary with the expansion joint device and bridge surface. (Partial damage may progress due to the impact load from the vehicle). | |

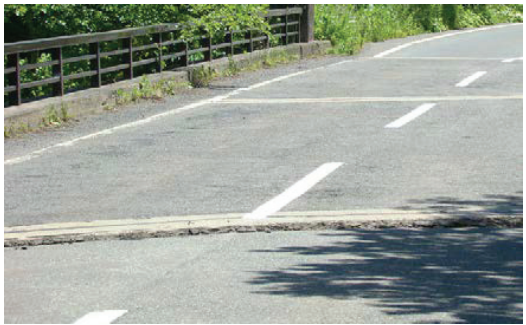
| Others | Irregularities of Road Surface | Road Surface |
|---|---|---|
| | There is a clear step at the boundary between the approach road and the bridge surface. (The step of the approach road could be as a result of settlement or due to an earthquake). | |

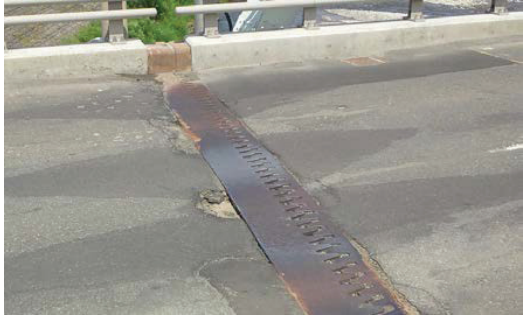
| Others | Irregularities of Road Surface | Road Surface |
|---|---|---|
| | Significant road surface irregularities at the boundary of spans. (The substructure may have subsidence, inclination, or damage of bearing). | |

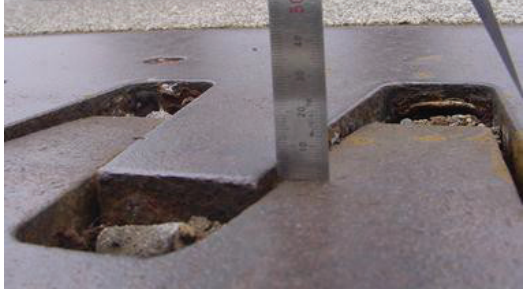
| Others | Irregularities of Road Surface | Road Surface |
|---|---|---|
| | There is a clear misalignment in the expansion joint devices. This could be due to the settlement on the approach road or the bearing being destroyed. | |

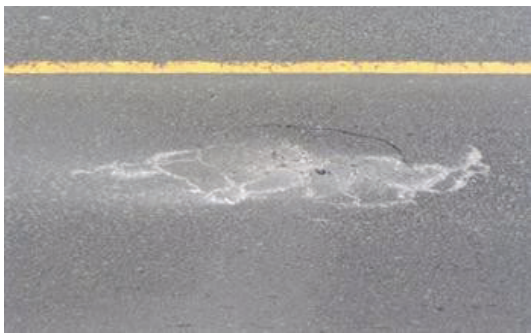
| Others | Abnormality on the Surfacing | Road Surface |
|---|---|---|
| | | <p>If the surfacing shows unusual damage, the concrete slab may be significantly damaged.</p> <p>(Example where the top surface of the concrete slab has turned into granulation).</p> |

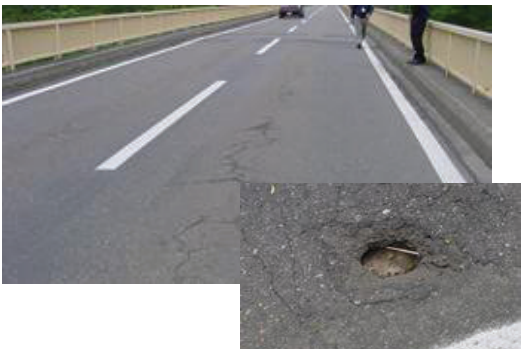
| Others | Abnormality on the Surfacing | Road Surface |
|---|---|---|
| | | <p>If the surfacing shows unusual damage, the concrete slab may be significantly damaged.</p> <p>For example:</p> <ul style="list-style-type: none"> <li>• Concrete slab has turned into granulation.</li> <li>• Fatigue cracks in steel plate floor.</li> </ul> |

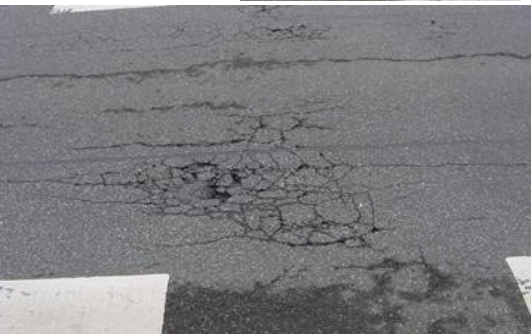
| Others | Abnormality on the Surfacing | Road Surface |
|---|---|---|
| | | <p>If the surfacing shows unusual damage, the concrete slab may be significantly damaged.</p> <p>For example:</p> <ul style="list-style-type: none"> <li>• Concrete slab has turned into granulation.</li> <li>• Fatigue cracks in steel plate floor.</li> </ul> |

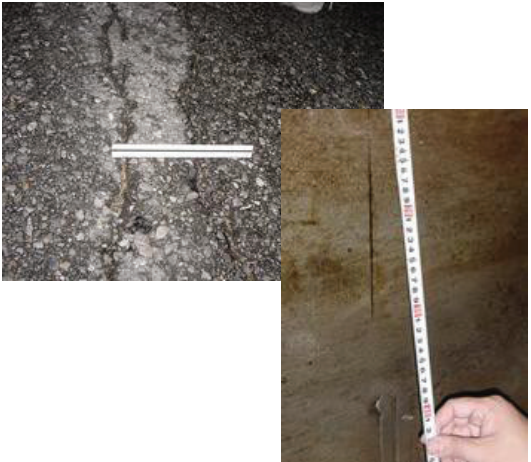
| Others | Abnormality on the Surfacing | Road Surface |
|---|---|---|
| | | <p>If the surfacing shows unusual damage, the concrete slab may be significantly damaged.</p> <p>(Example of cracks in the steel plate floor that penetrate the deck).</p> |

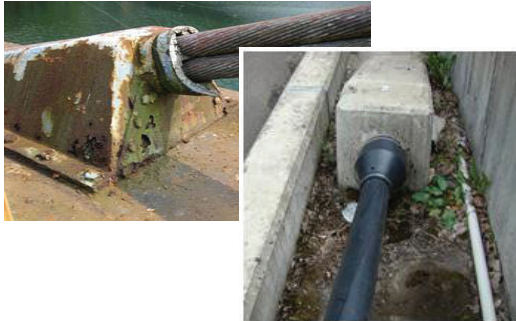
| Others | Abnormality in the Anchorage Part | Common |
|---|---|---|
| | | Corrosion protection of the fixing part of the cable member is deteriorated, or rainwater may penetrate into the fixing part. |

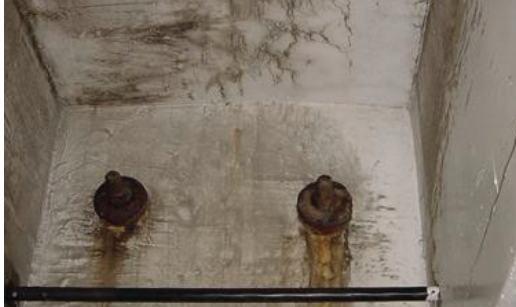
| Others | Abnormality in the Anchorage Part | Common |
|---|---|---|
| | | Significant rusting is observed at the fixing part of the girder connecting device. |

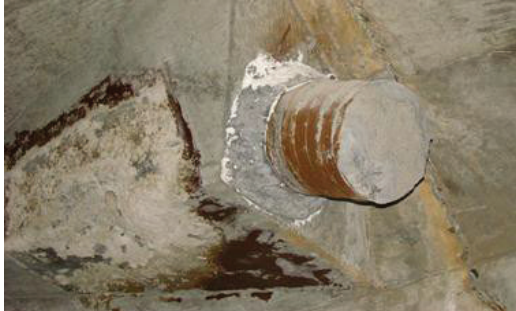
| Others | Abnormality in the Anchorage Part | Common |
|---|---|---|
| | | Rust and lime exudation can be seen in the PC steel material fixing part in the girder. (Rainwater may reach the fixing part or cable member from the road surface side such as the concrete slab top surface, and corrosion may progress). |

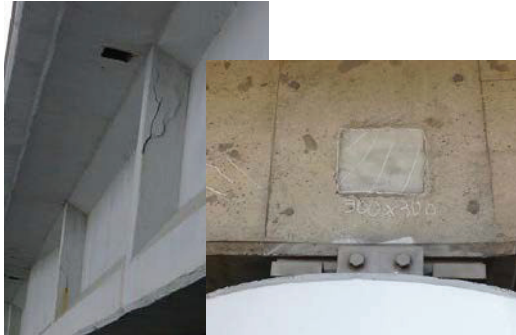
| Others | Abnormality in the Anchorage Part | Common |
|---|---|---|
| | | Horizontally tightened PC steel material is missing (In addition to the reduction in load bearing capacity, it may easily be damaged by a third party). |

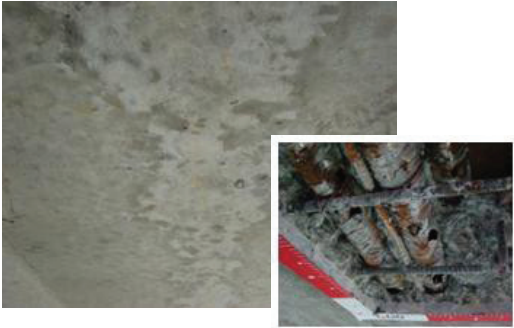
| Others | Discoloration/Deterioration | Common |
|---|---|---|
| | | If a characteristic discoloration is seen on the surface of the PC bridge, the internal PC steel may be significantly corroded. |

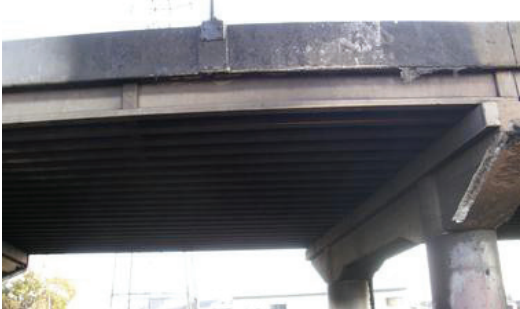
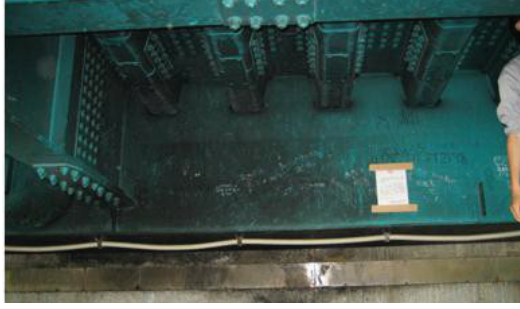
| Others | Discoloration/Deterioration | Common |
|---|---|---|
| | | If fire marks are seen, the strength of the member may have decreased. |
| | | If fire marks are seen, the strength of the member may have decreased. |

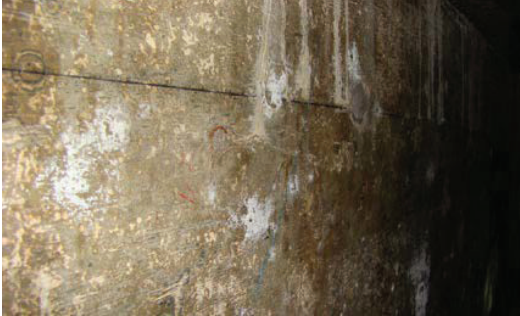
| Others | Discoloration/Deterioration | Common |
|---|---|---|
| | | If unusual discoloration is seen on the surface of the concrete member, a unique color may appear in the infiltrated state due to alteration of aggregate. |

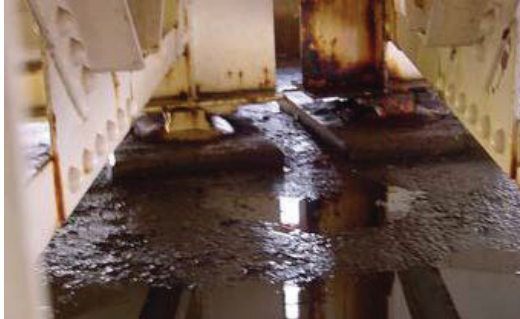
| Others | Water Leakage/Water Retention | Common |
|---|---|---|
| | | Significant water leakage is seen between the girders. (On the upper surface of the substructure, water such as water leakage may not be promptly removed, which may cause long-term water retention). |

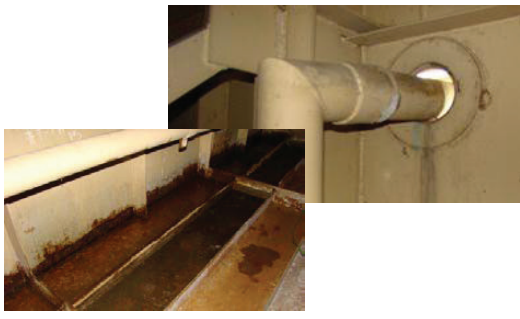
| Others | Water Leakage/Water Retention | Common |
|---|---|---|
| | | Water has accumulated inside the member such as the box girder. (If water leaks into the member due to gaps in the member or damage of the drainage facility, water may be retained). |

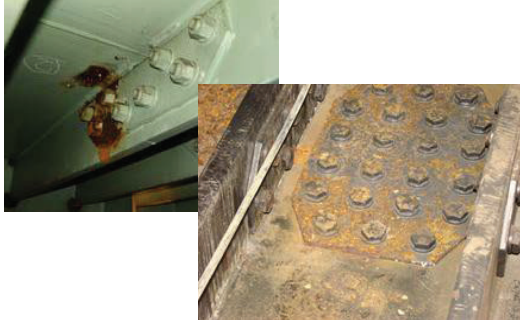
| Others | Water Leakage/Water Retention | Common |
|---|---|---|
| | | Water has accumulated inside the member such as the box girder. (If water leaks into the member due to gaps in the member or damage of the drainage facility, water may be retained). |

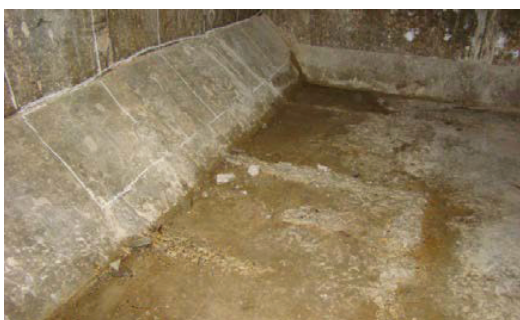
| Others | Water Leakage/Water Retention | Common |
|---|---|---|
| | | Water has accumulated inside the member such as the box girder. (If water leaks due to cracks or damage of drainage facilities, water may retain inside the members). |

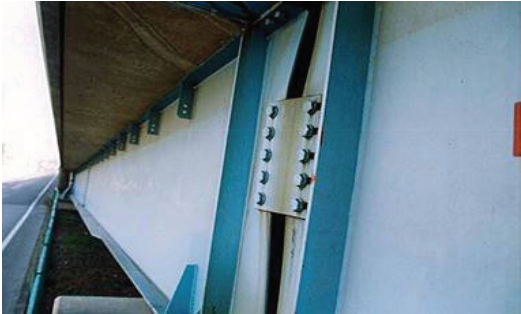
| Others | Deformation/Defect | Common |
|---|---|---|
| | Large deformation or defect of structural member (Various deformations may occur in areas other than the relevant area due to vehicle collisions or interference between members). | |

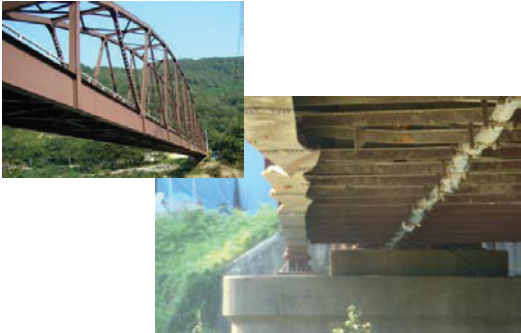
| Others | Deformation/Defect | Common |
|---|---|---|
| | Large deformation or defect of main girder (In the event of a flood or tsunami, floating debris may collide and damage structural member). | |

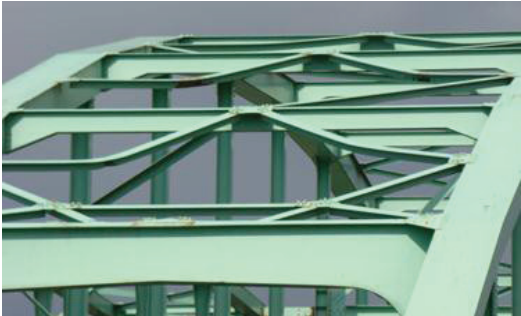
| Others | Deformation/Defect | Common |
|---|---|---|
| | Significant deformation is seen in the upper lateral bracing. (During an earthquake, a large horizontal force may cause deformation or rupture of lateral members). | |

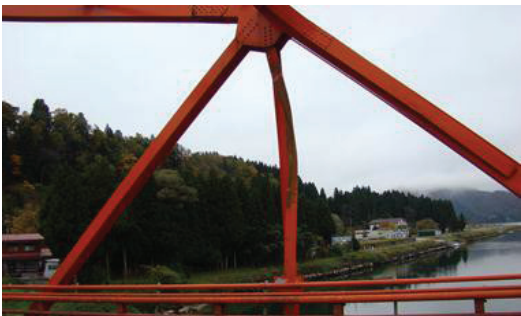
| Others | Deformation/Defect | Common |
|---|---|---|
| | Significant deformation is seen in the vertical members of the truss bridge. (The members may be deformed or ruptured as a result of being knocked by vehicles). | |

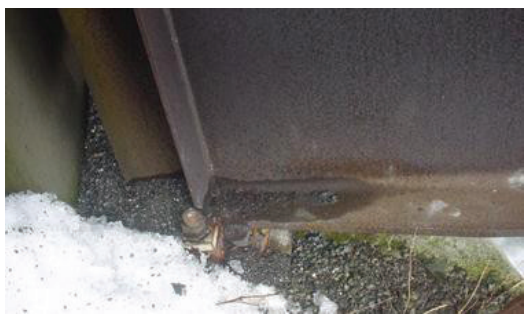
| Others | Sediment Clogging | Common |
|---|---|---|
| | Sediment is deposited on the bearing.<br>(It may lead to functional impairment such as promoting corrosion of bearings). | |

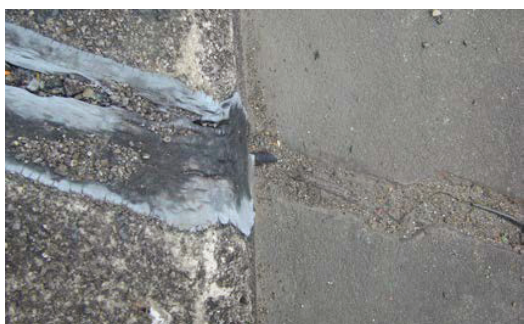
| Others | Sediment Clogging | Common |
|---|---|---|
| | The expansion joint device is clogged with debris and sand. | |

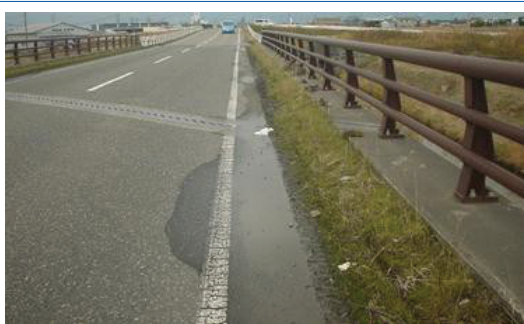
| Others | Sediment Clogging | Common |
|---|---|---|
| | The catch-basin is clogged with debris, causing poor drainage on the road surface. | |

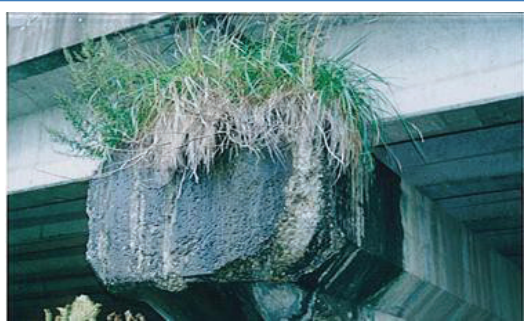
| Others | Sediment Clogging | Common |
|---|---|---|
| | Sediment is accumulated on the bridge support surface. (Because of the environmental conditions of the bridge that are prone to water retention, concrete deterioration may occur). | |

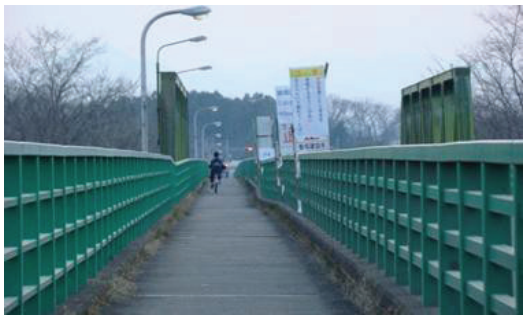
| Others | Subsidence/Movement/Inclination | Common |
|---|---|---|
| | | Deformation can be seen on the entire bridge. (The entire bridge may be in a dangerous state due to the inclination or subsidence of the substructure). |

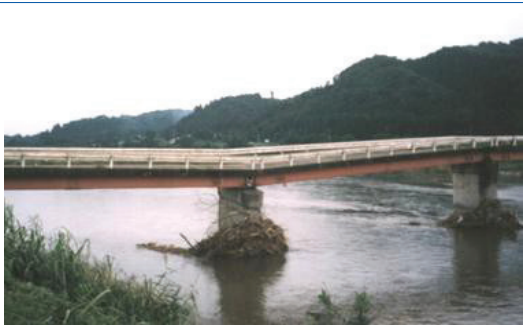
| Others | Subsidence/Movement/Inclination | Common |
|---|---|---|
| | | Deformation of the entire bridge can be seen on the river bridge.<br>(It may be in a dangerous state due to scouring or subsidence of substructure). |

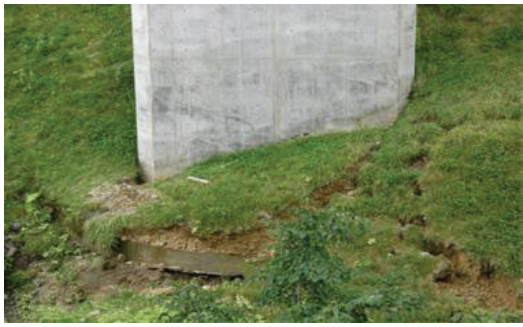
| Others | Subsidence/Movement/Inclination | Common |
|---|---|---|
| | | There is a possibility that the substructure is displaced. (If there is a deformation of the ground around the substructure, the entire bridge may be in a dangerous state.) |

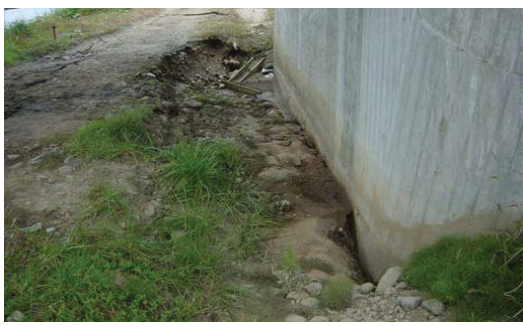
| Others | Subsidence/Movement/Inclination | Common |
|---|---|---|
| | | Traces of earth and sand can be seen around the substructure.<br>(If liquefaction occurs, the substructure may have subsidence or inclination).<br><b>Note:</b> It is unknown whether there are any abnormalities in the case of the photo. |

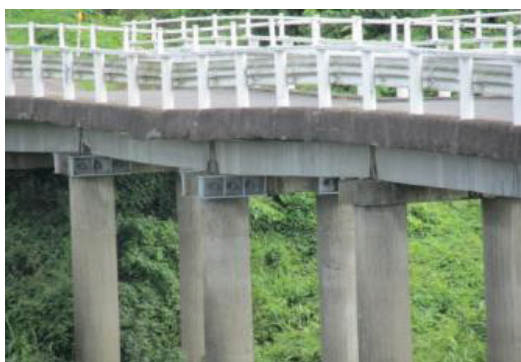
| Others | Subsidence/Movement/Inclination | Common |
|---|---|---|
| | <p>Deformation of the entire bridge can be seen on the bridge.</p> <p>(It may be in a dangerous state due to scouring or subsidence of substructure).</p> | |

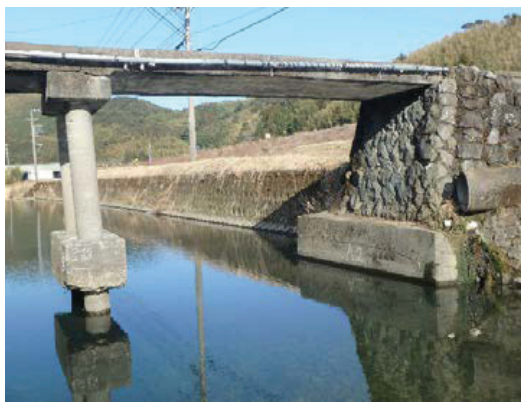
| Others | Subsidence/Movement/Inclination | Common |
|---|---|---|
| | <p>Deformation of the entire bridge can be seen on the bridge.</p> <p>(It may be in a dangerous state due to scouring or subsidence of substructure).</p> | |

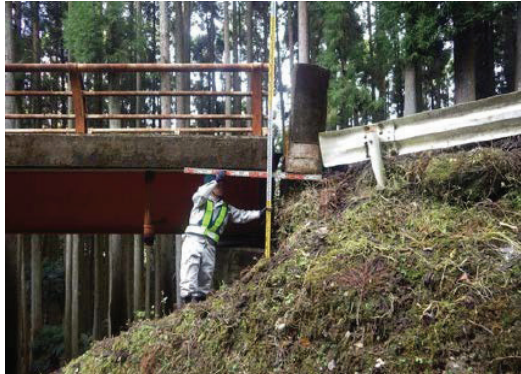
| Others | Subsidence/Movement/Inclination | Common |
|---|---|---|
| | <p>Suspected that the abutment is subsiding, moving, or inclining due to collapse of back embankment (If there is a deformation of the ground around the substructure, the entire bridge may be in a dangerous state).</p> | |

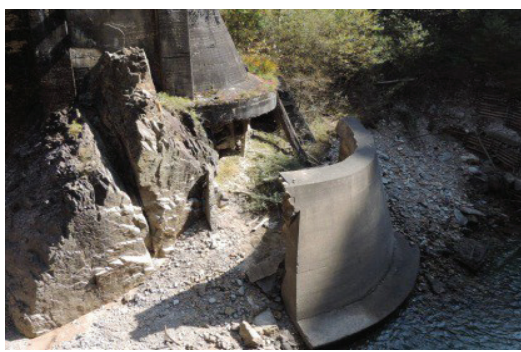
| Others | Subsidence/Movement/Inclination | Common |
|---|---|---|
| | <p>The retaining wall which protects the substructure has subsided due to scouring.</p> | |

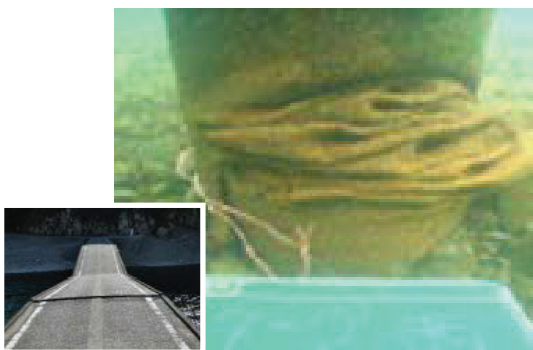
| Others | Subsidence/Movement/Inclination | Common |
|---|---|---|
| | | <p>Buckling of steel pile-bent piers has caused subsidence of superstructure.</p> <p>(The stability of the substructure may be impaired and the bridge may be in a dangerous state).</p> |

| Others | Subsidence/Movement/Inclination | Common |
|---|---|---|
| <ul style="list-style-type: none"> <li>In the case that it is not possible to directly check the condition of the steel pile-bent pier underwater, it may be effective to directly check with a diver or use an underwater camera.</li> </ul> | | |

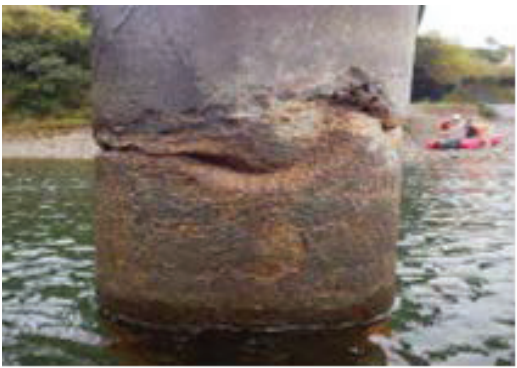
| Others | Subsidence/Movement/Inclination | Common |
|---|---|---|
| | | <p>Steel pile-bent pier is buckled. (There is a risk of rapid deformation).</p> |

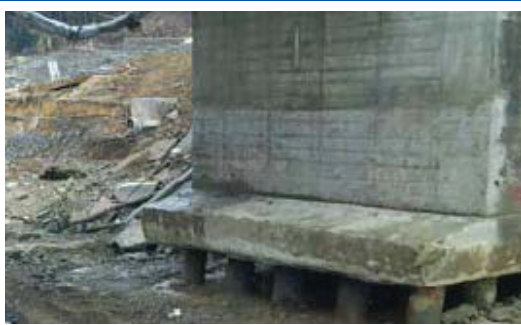
| Others | Scouring | Substructure |
|---|---|---|
| | The foundation is scoured and the piles are exposed. (Damage discovered after the tsunami). | |

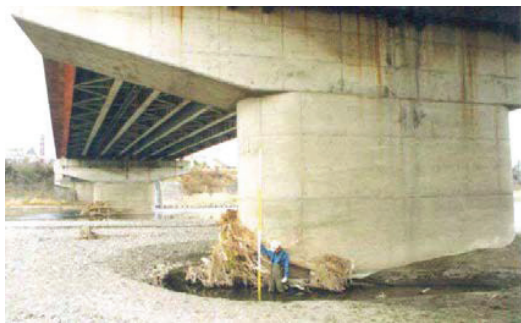
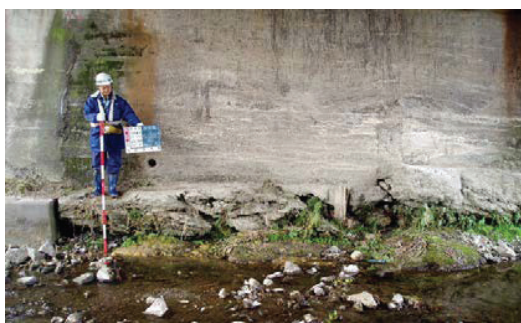
| Others | Scouring | Substructure |
|---|---|---|
| | The foundation is scoured remarkably due to flowing water. | |
| | The foundation is scoured remarkably due to flowing water. | |

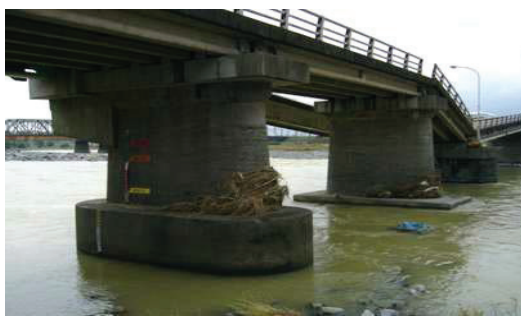
| Others | Scouring | Substructure |
|---|---|---|
| | Scour is progressing due to flood.<br><br>(As scouring progresses, the pier may subside or incline). | |

| Others | Scouring | Substructure |
|---|---|---|
| <ul style="list-style-type: none"><li>• In case deposits are accumulated in the scour area, it is often impossible to expect ground resistance.</li><li>• If it is not possible to directly check the condition of the foundation, it is necessary to check with a camera, etc., if required.</li></ul> | | |

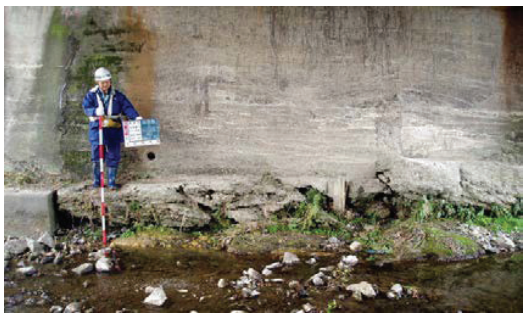
| Others | Soil Suck-out | Substructure |
|---|---|---|
| | | <p>There is a possibility that cavities may occur on the bottom surface of the abutment foundation due to scouring.</p> |

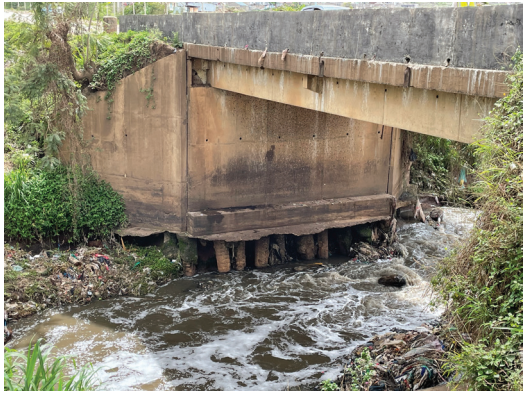
| Others | Soil Suck-out | Substructure |
|---|---|---|
| | | <p>The ground on the foundation of abutment is scoured and the embankment soil on the back of the abutment flowed out.</p> |

| Others | Soil Suck-out | Substructure |
|---|---|---|
| <ul style="list-style-type: none"> <li>If the backfill of the bridge is eroded, abnormalities such as cracks and depressions may appear on the road surface.</li> </ul> | | |

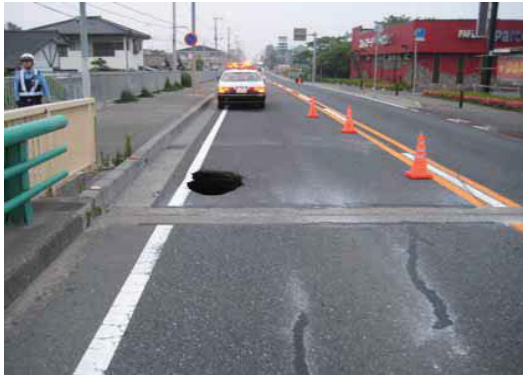
| Others | Soil Suck-out | Substructure |
|---|---|---|
| | | <p>(If abnormalities appear on the surfacing, it may be due to the erosion of the backfill).</p> |

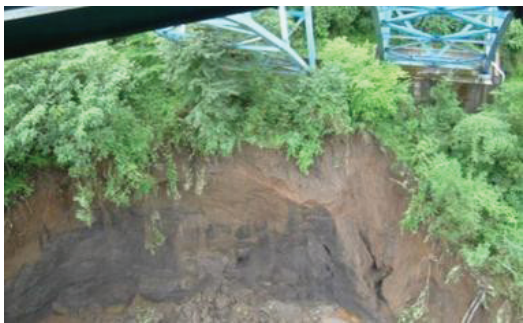
| Others | Other Abnormalities | Common |
|---|---|---|
| | <p>Significant deformation in the ground near the foundation. (The entire bridge may be in a dangerous state because the stability of the substructure has been impaired).</p> | |

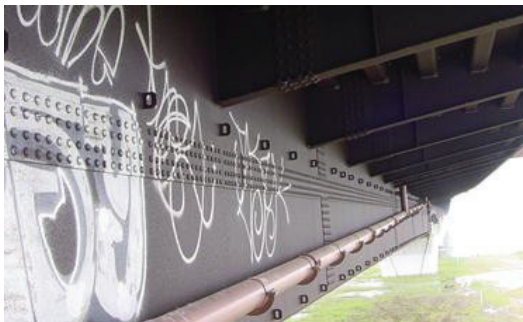
| Others | Other Abnormalities | Common |
|---|---|---|
| | <p>Large graffiti is seen. (Graffiti may adversely affect anticorrosion coatings such as painting, or may hinder the formation of protective rust on atmospheric corrosion resisting steel material).</p> | |

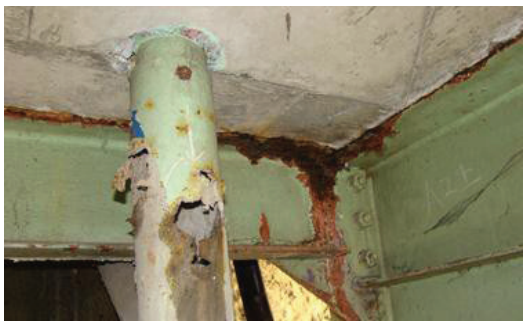
| Others | Other Abnormalities | Common |
|---|---|---|
| | <p>The section is missing due to corrosion of the drainage pipe. (Damage of the drainage pipe may seriously affect the bridge body due to leaking drainage).</p> | |

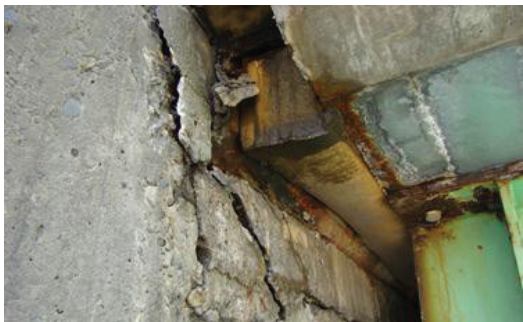
| Others | Other Abnormalities | Common |
|---|---|---|
| | <p>Girder-end collides with substructure. (If there is no clearance between the girder-end and the substructure, a large force may be applied to both structure, which may lead to buckling of the girder or damage to the abutment).</p> | |

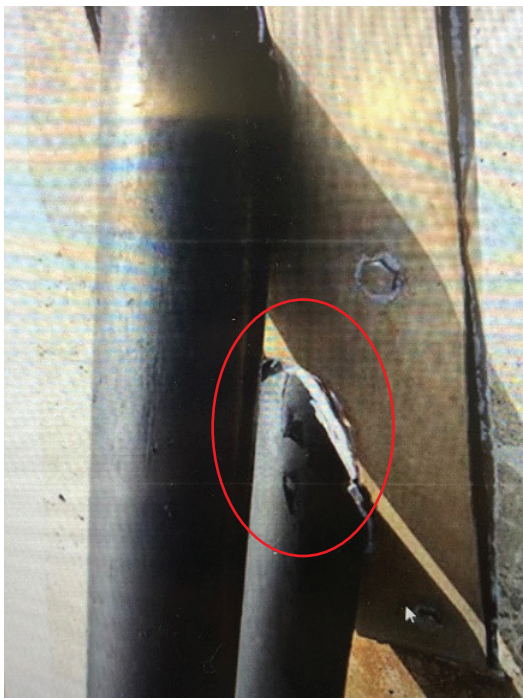
| Others | Others | Cable |
|---|---|---|
| | | <p>Crack on Coating Material.</p> <p>Severity : DL I</p> |

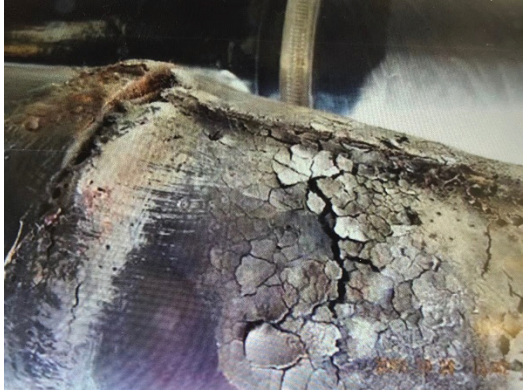
| Others | Others | Cable |
|---|---|---|
| | | <p>Crack on Coating Material.</p> <p>Severity : DL II</p> |

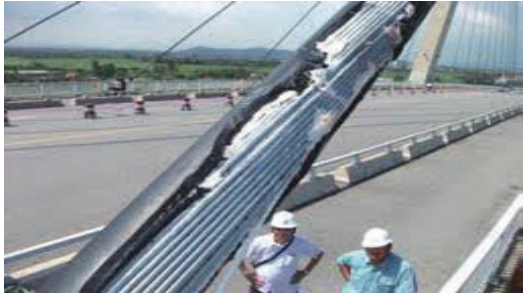
| Others | Others | Cable |
|---|---|---|
| | | <p>Peeling of Coating Material.</p> <p>Measures must be taken to prevent water from entering the strands.</p> <p>Severity : DL III</p> |

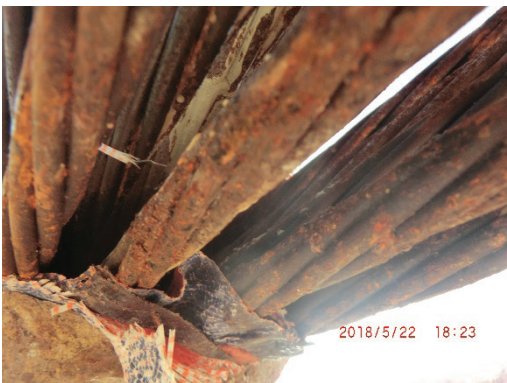
| Others | Others | Cable |
|---|---|---|
| | Rust/Corrosion on Strand.<br>Severity: I | |

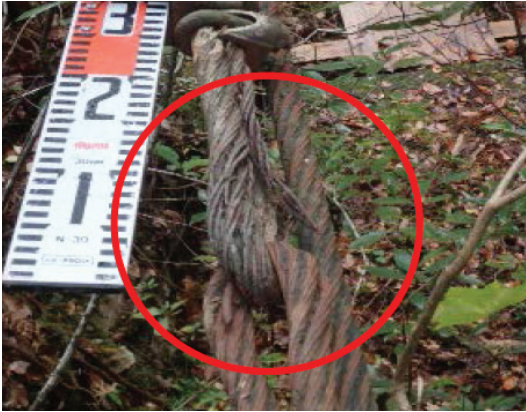
| Others | Others | Cable |
|---|---|---|
| | Crack on Coating Material.<br>Severity : II | |

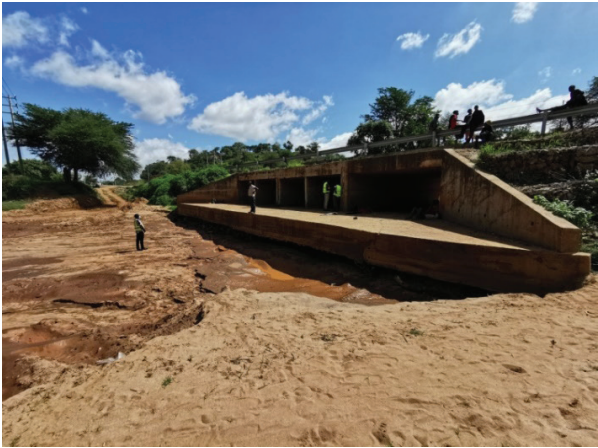
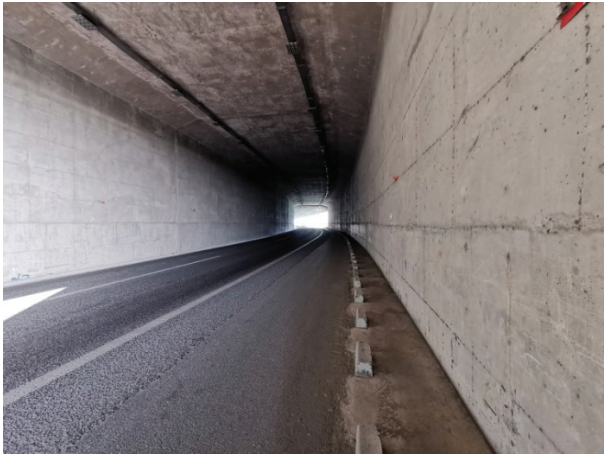
| Structural deterioration | Response Time | Image (Bad) | Image (Good) |
|---|---|---|---|
| Concrete bridges must be in good condition and fully functional. | In case of structural damage, the Contractor to notify the Engineer within 24 hours. | | |

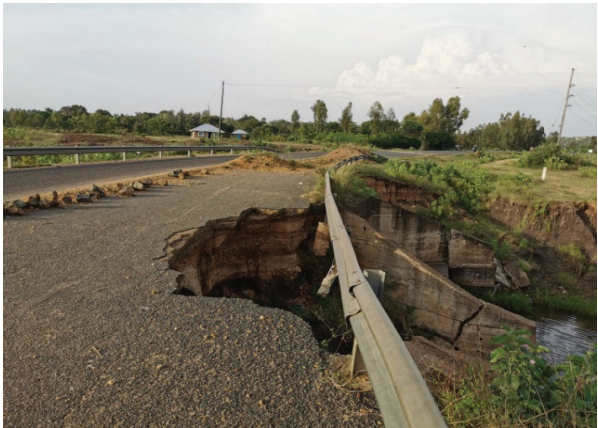
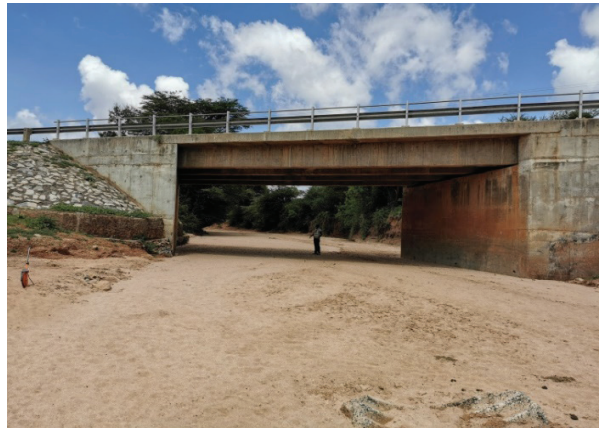
| Structural deterioration | Response Time | Image (Bad) | Image (Good) |
|---|---|---|---|
| Concrete bridges must be in good condition and fully functional. | In case of structural damage, the Contractor to notify the Engineer within 24 hours. | | |

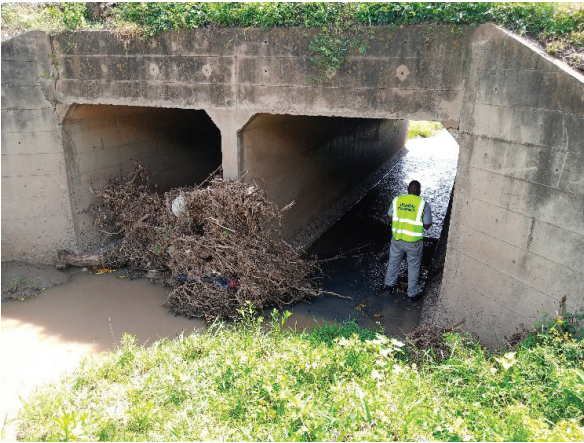
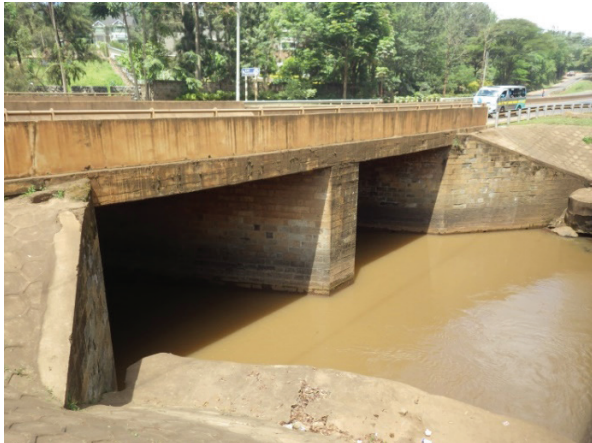
| Structural deterioration | Response Time | Image (Bad) | Image (Good) |
|---|---|---|---|
| Concrete bridges must be in good condition and fully functional. | In case of structural damage, the Contractor to notify the Engineer within 24 hours. | | |

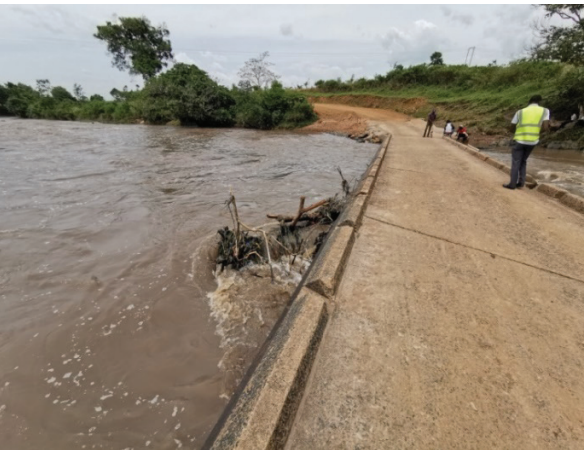
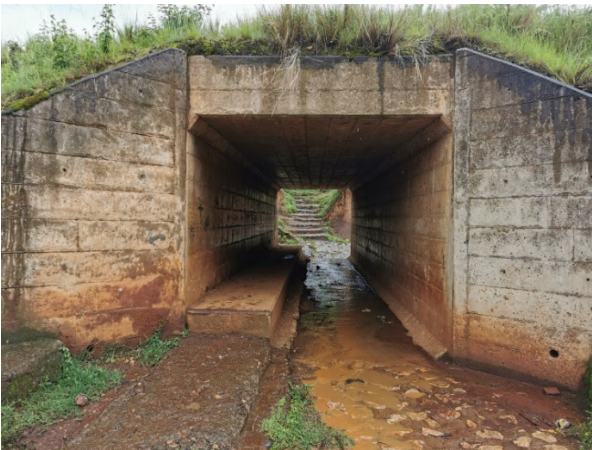
| Structural deterioration | Response Time | Image (Bad) | Image (Good) |
|---|---|---|---|
| Obstructions due to debris or inappropriate vegetation. | Any accumulation of debris <400 mm must be removed. | | |

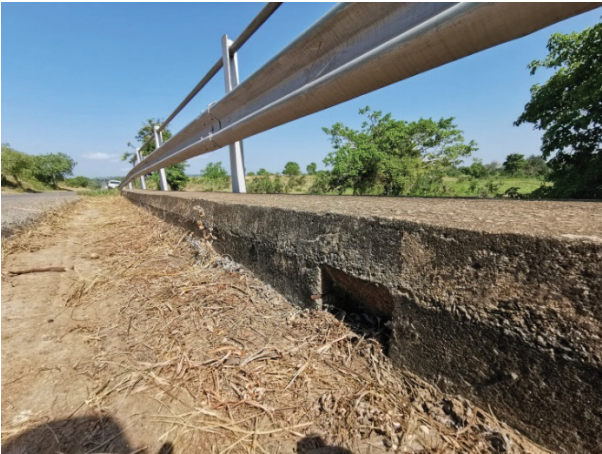
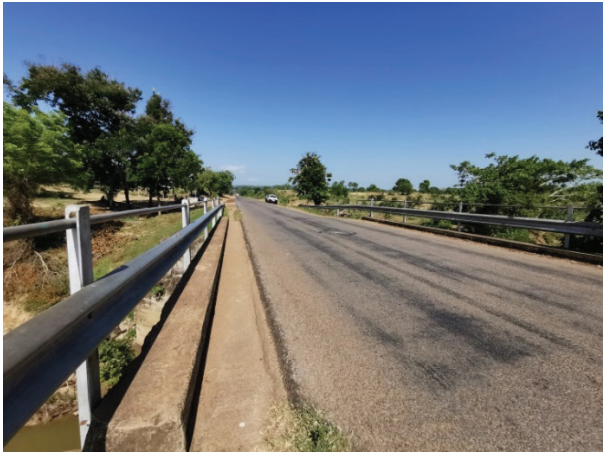
| Structural deterioration | Response Time | Image (Bad) | Image (Good) |
|---|---|---|---|
| Obstructions due to debris or inappropriate vegetation. | Any accumulation of debris <400 mm must be removed. | | |

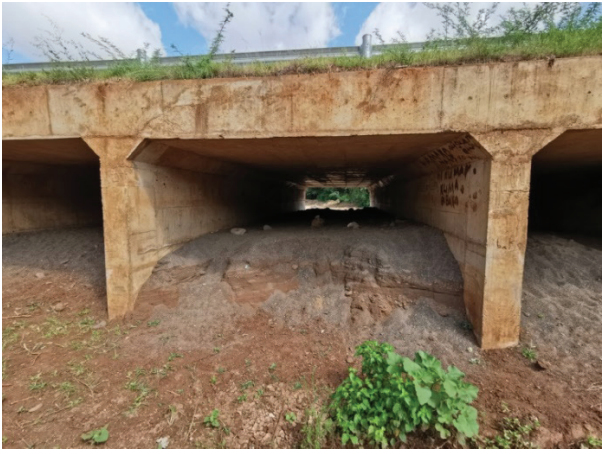
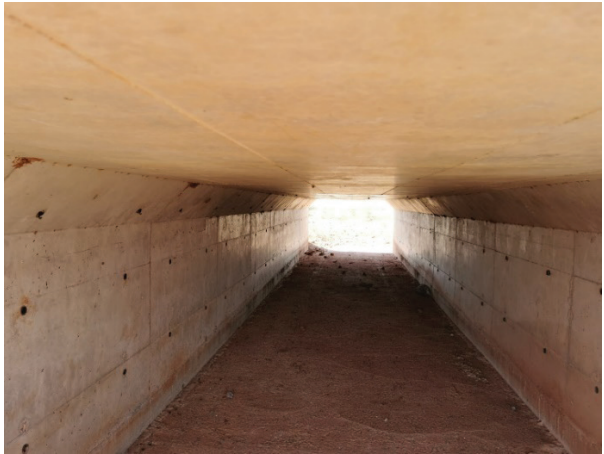
| Structural deterioration | Response Time | Image (Bad) | Image (Good) |
|---|---|---|---|
| Obstructions due to debris or inappropriate vegetation. | Any accumulation of debris <400 mm must be removed. | | |
