# BRIDGE INSPECTION MANUAL

FOR ARBICS AND PBC

The Project for Strengthening of Capacity Development on  
Bridge Management System in the Republic of Kenya

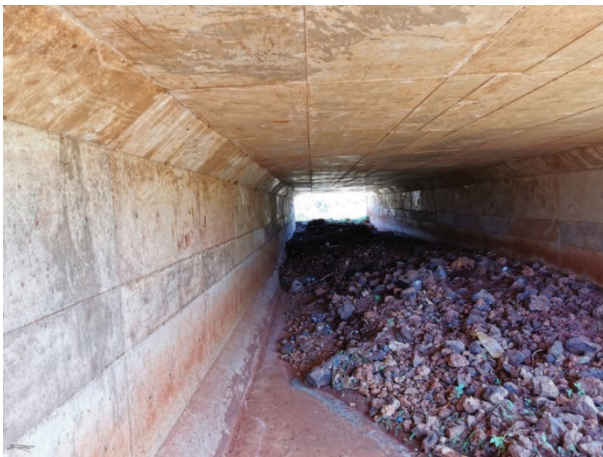
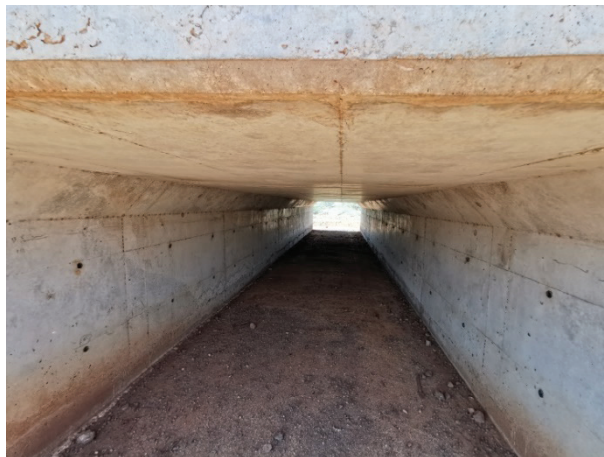
| Structural deterioration | Response Time | Image (Bad) | Image (Good) |
|---|---|---|---|
| Obstructions due to debris or inappropriate vegetation. | Any accumulation of debris <400 mm must be removed. | | |

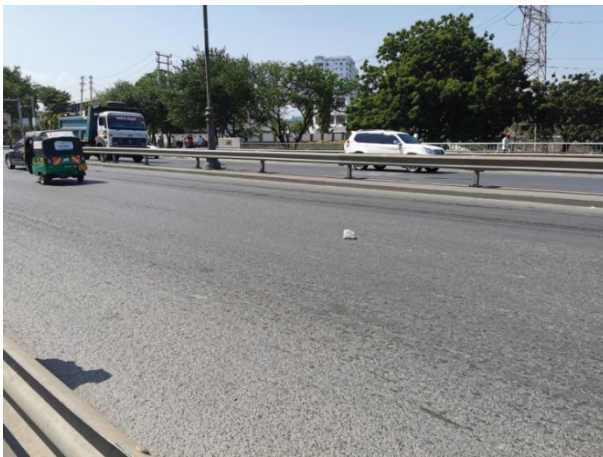
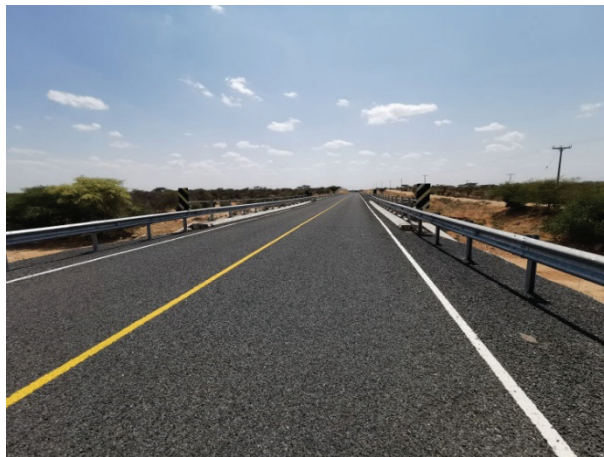
| Structural deterioration | Response Time | Image (Bad) | Image (Good) |
|---|---|---|---|
| Obstructions due to debris or inappropriate vegetation. | Any accumulation of debris <400 mm must be removed. | | |

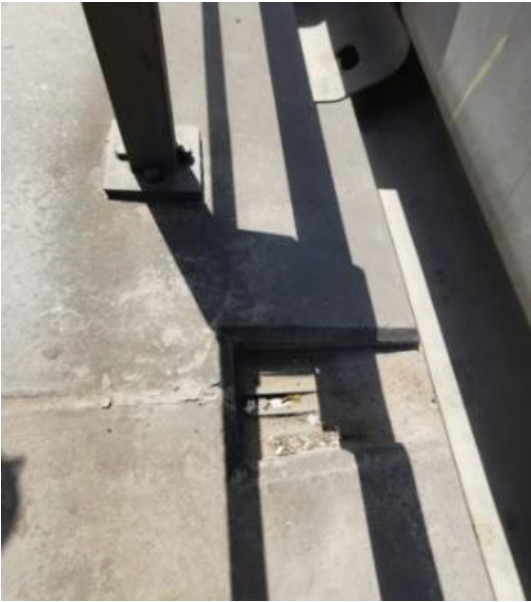
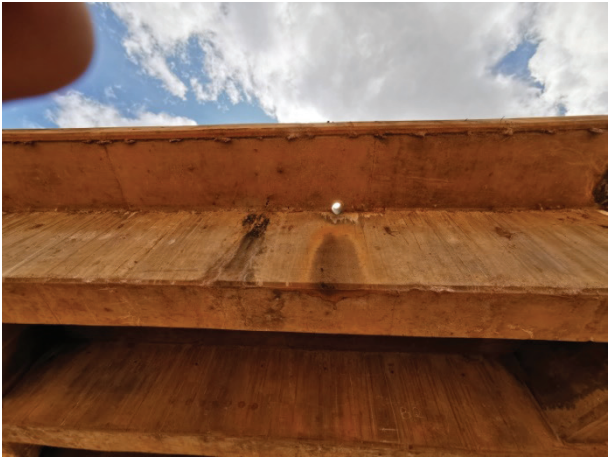
| Structural deterioration | Response Time | Image (Bad) | Image (Good) |
|---|---|---|---|
| Obstructions due to debris or inappropriate vegetation. | Any accumulation of debris <400 mm must be removed. | | |

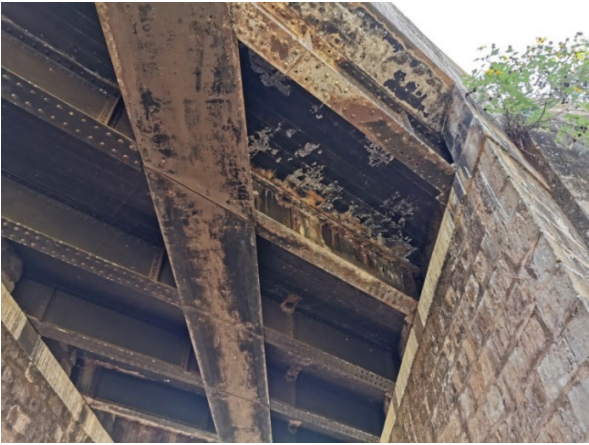
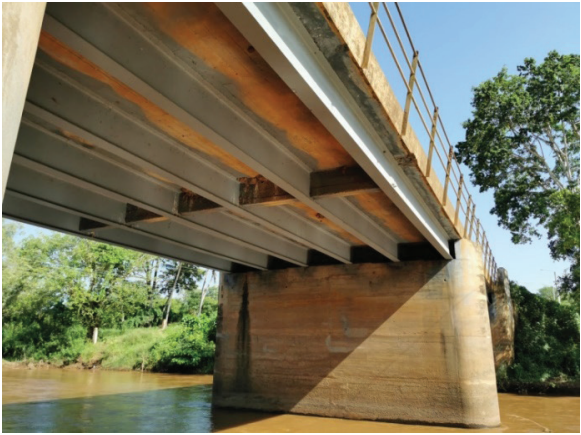
| Structural deterioration | Response Time | Image (Bad) | Image (Good) |
|---|---|---|---|
| Structural deterioration, Leaking structures. | In case of structural damage, the Contractor to notify the Engineer within 24 hours. | | |

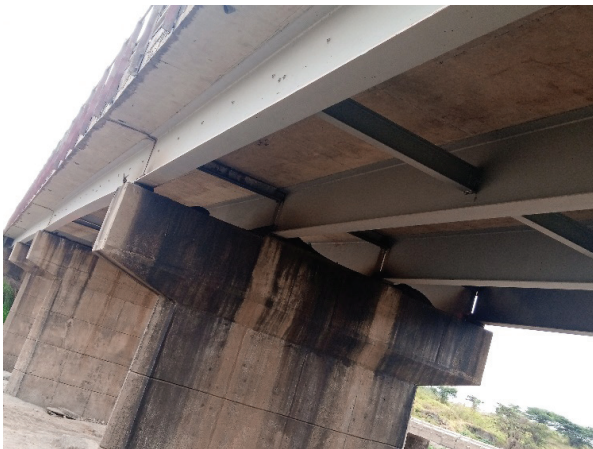
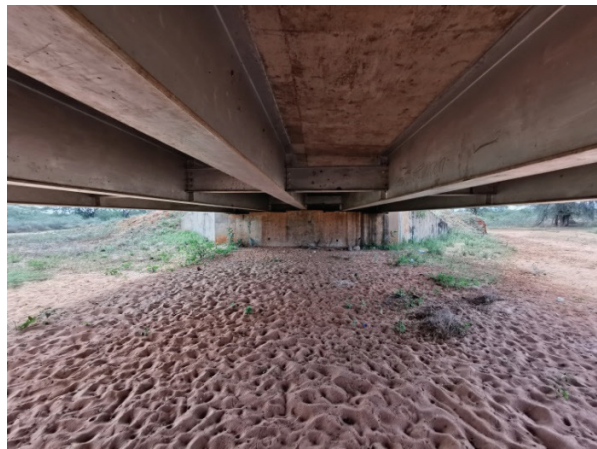
| Structural deterioration | Response Time | Image (Bad) | Image (Good) |
|---|---|---|---|
| Structural deterioration,<br>Leaking bridges. | In case of structural damage, the Contractor to notify the Engineer within 24 hours. | | |

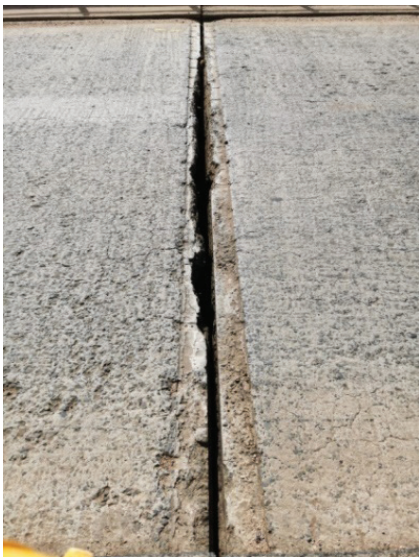
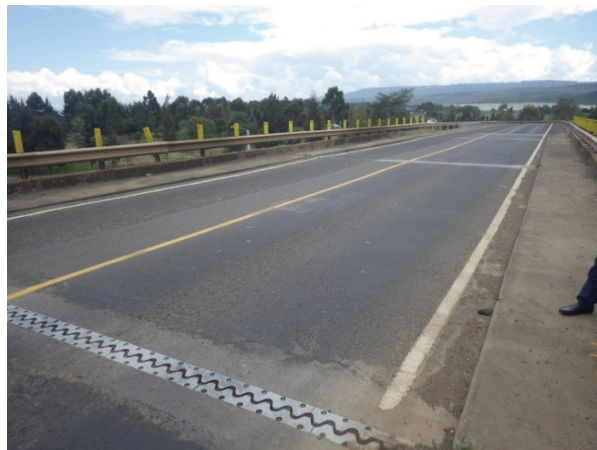
| Structural deterioration | Response Time | Image (Bad) | Image (Good) |
|---|---|---|---|
| Debris impeding joint movement/damaging the joint. | In case of structural damage, the Contractor to notify the Engineer within 24 hours. | | |

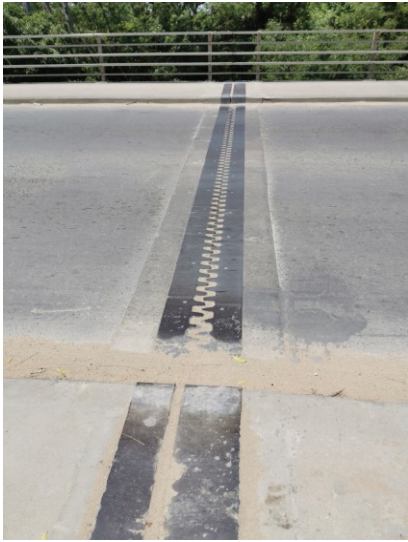
| Structural deterioration | Response Time | Image (Bad) | Image (Good) |
|---|---|---|---|
| Debris impeding joint movement/damaging the joint. | In case of structural damage, the Contractor to notify the Engineer within 24 hours. | | |

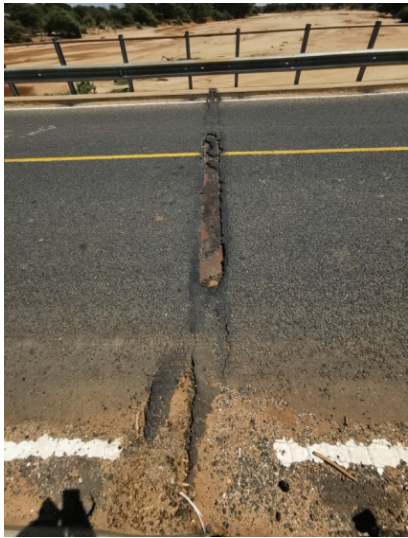
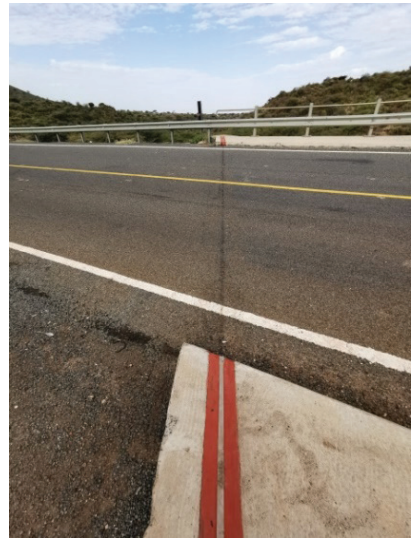
| Structural deterioration | Response Time | Image (Bad) | Image (Good) |
|---|---|---|---|
| Debris impeding joint movement/damaging the joint. | In case of structural damage, the Contractor to notify the Engineer within 24 hours. | | |

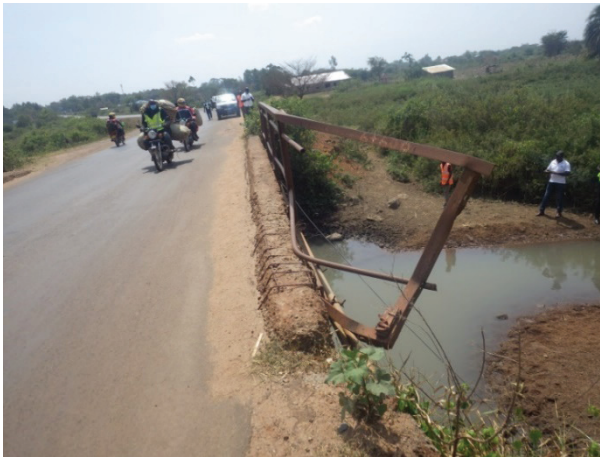
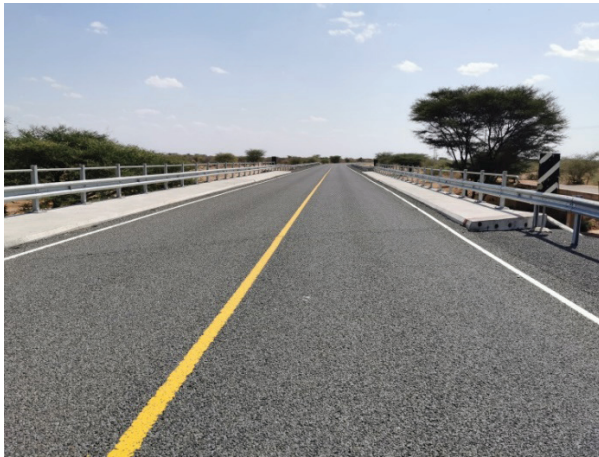
| Structural deterioration | Response Time | Image (Bad) | Image (Good) |
|---|---|---|---|
| Deformed / Missing guardrails. | Damages and defects must be repaired within 2 weeks after detection. | | |

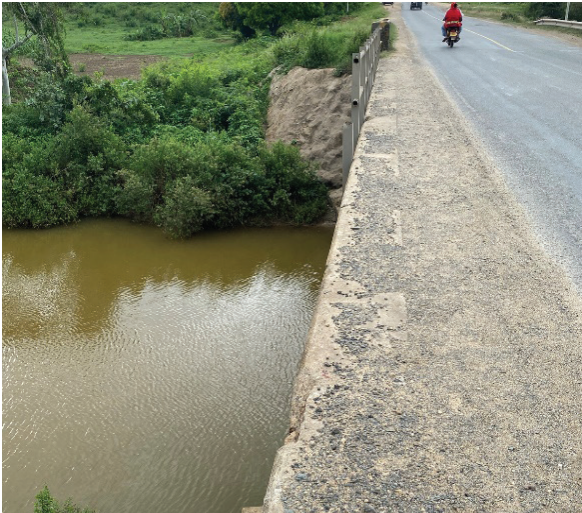
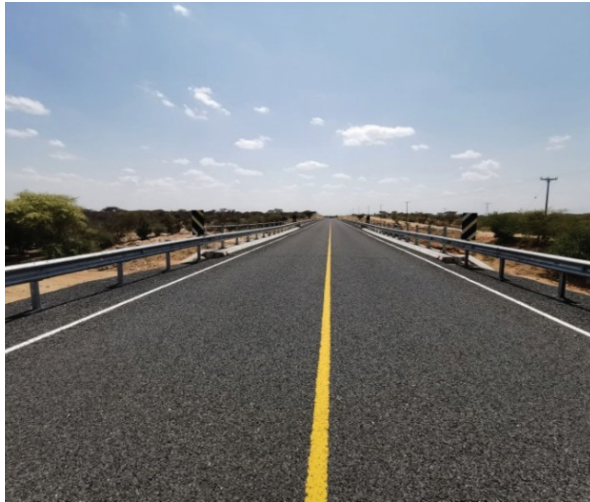
| Structural deterioration | Response Time | Image (Bad) | Image (Good) |
|---|---|---|---|
| Deformed / Missing guardrails. | Damages and defects must be repaired within 2 weeks after detection. | | |

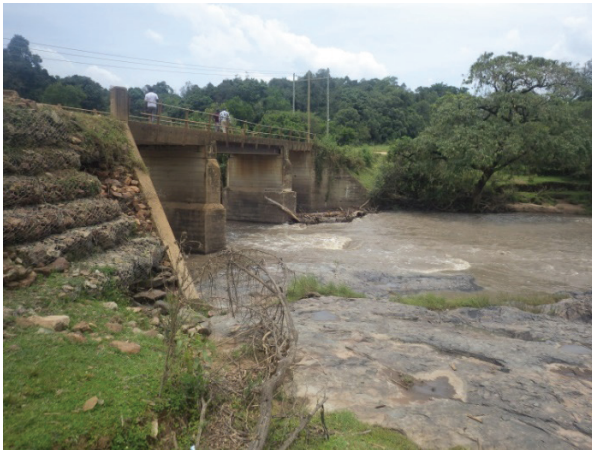
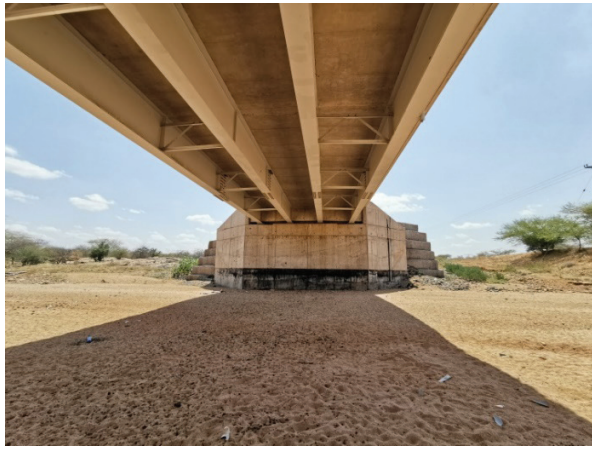
| Structural deterioration | Response Time | Image (Bad) | Image (Good) |
|---|---|---|---|
| Obstructions due to debris or inappropriate vegetation. | Any accumulation of debris <400 mm must be removed. | | |

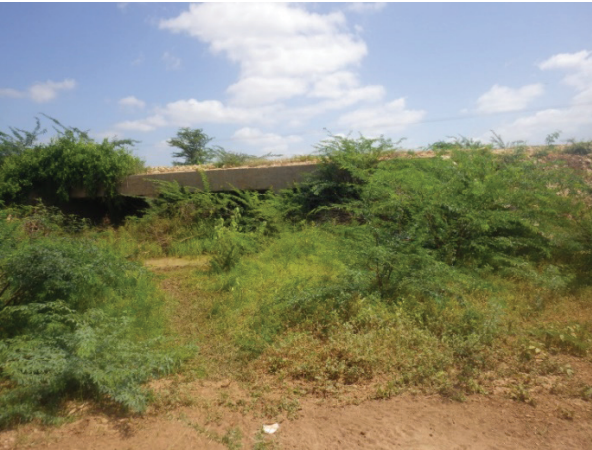
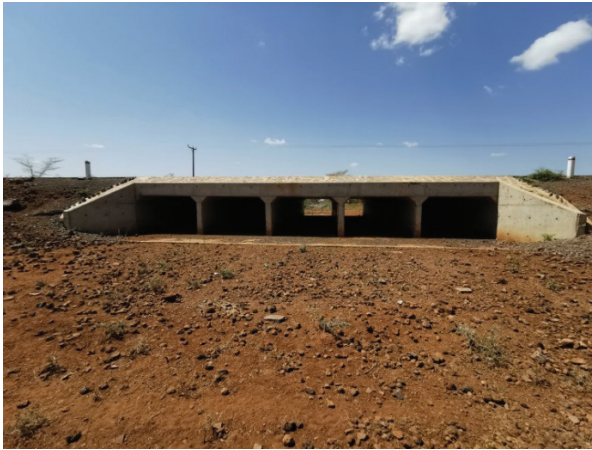
| Structural deterioration | Response Time | Image (Bad) | Image (Good) |
|---|---|---|---|
| Obstructions due to debris or inappropriate vegetation. | Any accumulation of debris <400 mm must be removed. | | |

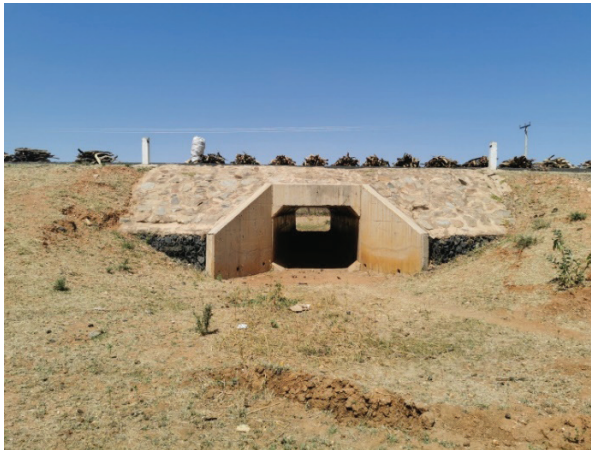
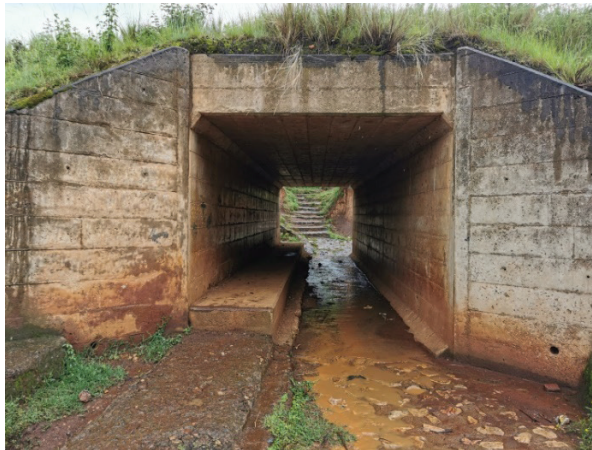
| Structural deterioration | Response Time | Image (Bad) | Image (Good) |
|---|---|---|---|
| Eroded river beds | Erosion around bridge abutments and piers must be controlled with all reasonable measures at all times. | | |

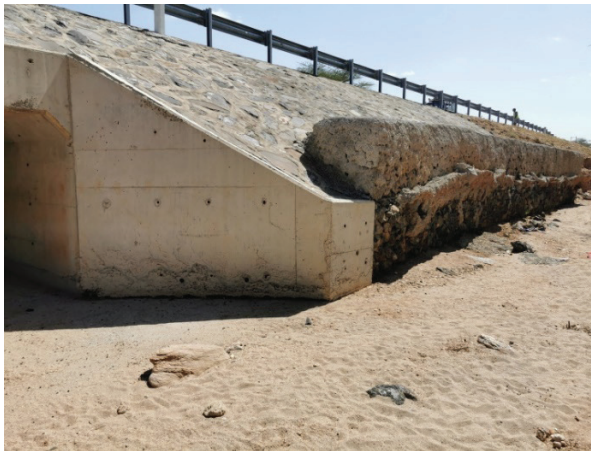
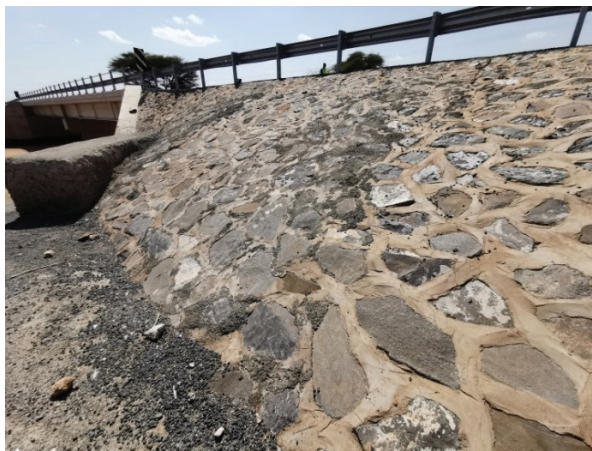
| Structural deterioration | Response Time | Image (Bad) | Image (Good) |
|---|---|---|---|
| Eroded slope protection | Must be fully functional with no serious defects that can endanger the structure | | |
